### A MULTI-JURISDICTIONAL COMPREHENSIVE PLAN FOR KENOSHA COUNTY: 2035 MAP AMENDMENT APPLICATION

# LAND USE PLAN MAP AMENDMENT EXHIBIT

A PARCEL OF LAND LOCATED IN THE SOUTHWEST 1/4 OF THE SOUTHEAST 1/4 OF SECTION 31, TOWNSHIP 2 NORTH, RANGE 19 EAST, IN THE TOWN OF WHEATLAND, KENOSHA COUNTY, WISCONSIN.

Wetland & Waterway Consulting (WWC) has conducted a wetland delineation on property located in Sec.31, T2N, R19E, Town of Wheatland, Kenosha County. The delineation was conducted on 7-13-20 at your request. This site is under consideration for future development; therefore, location of the presence or absence of wetlands prior to construction is necessary.

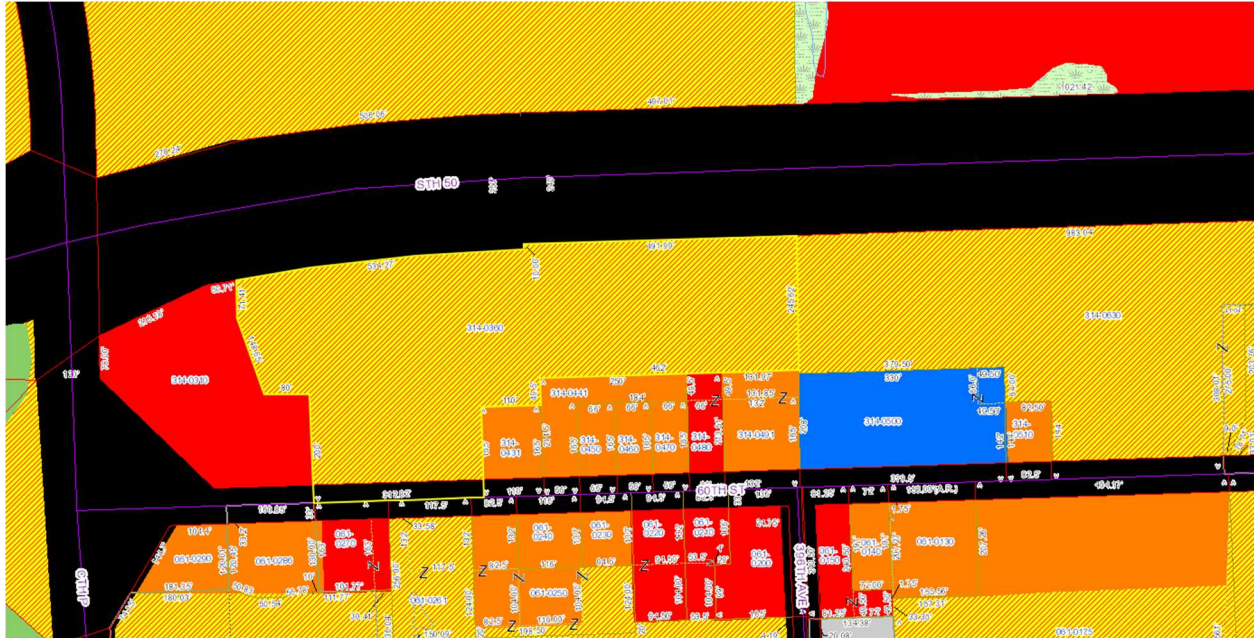
The Land Use Plan for this area designates this property as Suburban-Density Residential. The same is for the property to the North and East. To the west is designated Commercial along with Northeast and some other surrounding properties. There are also Medium-Density Residential and Government/Institutional in the vicinity.

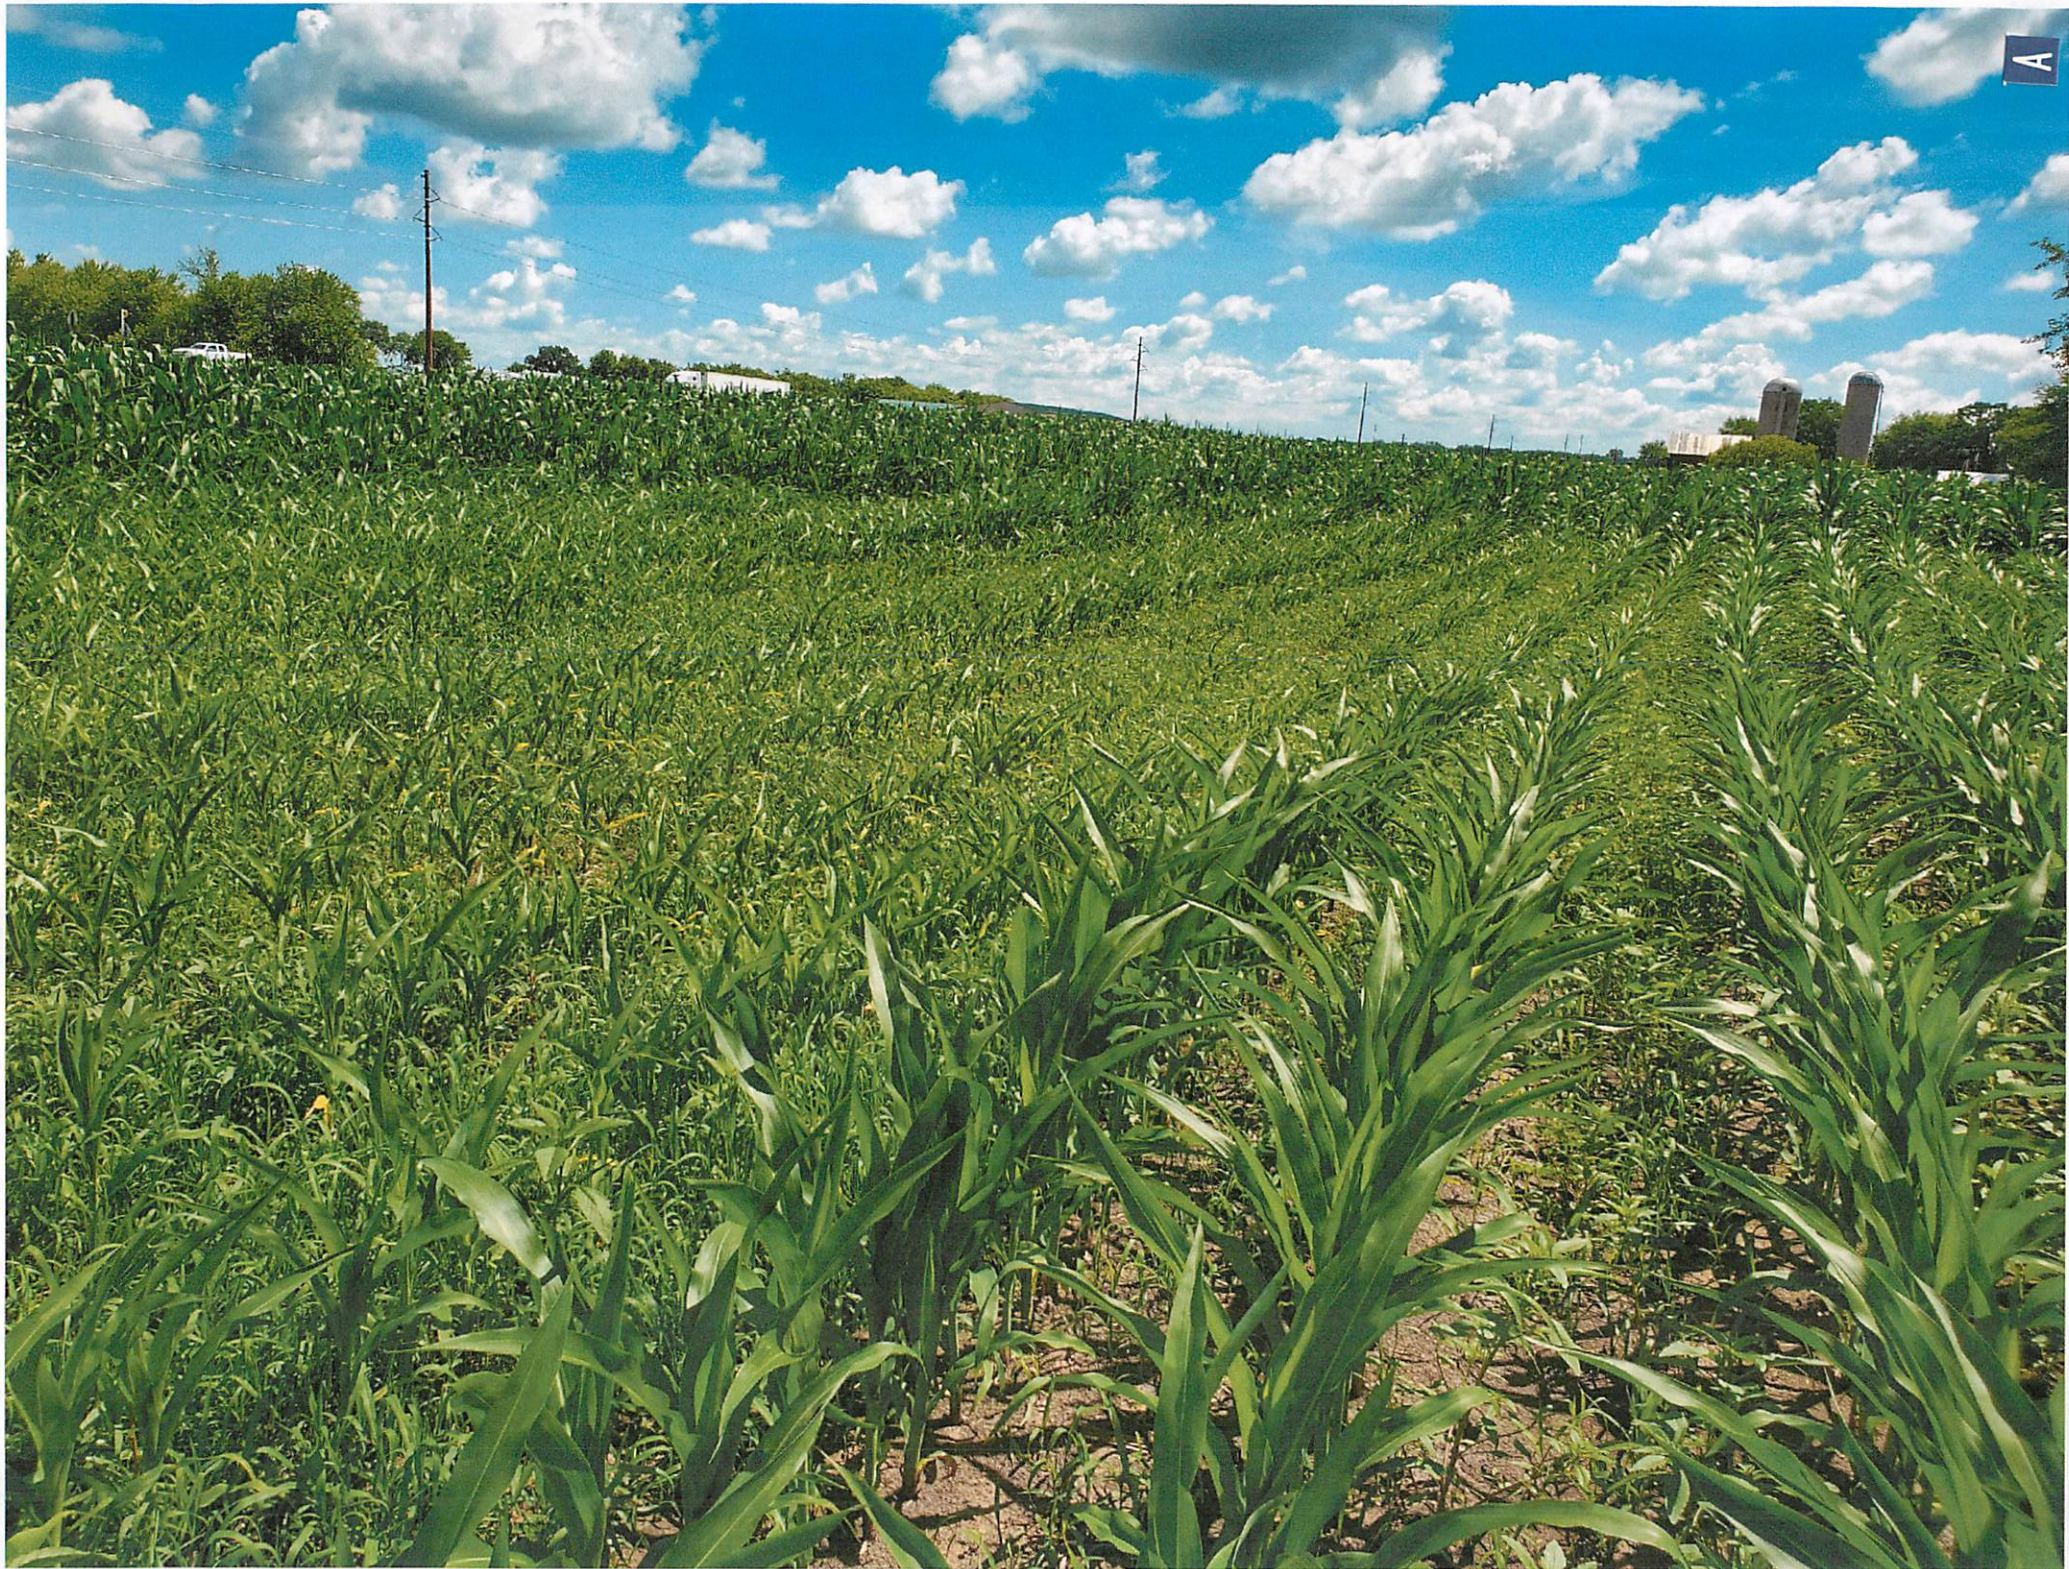
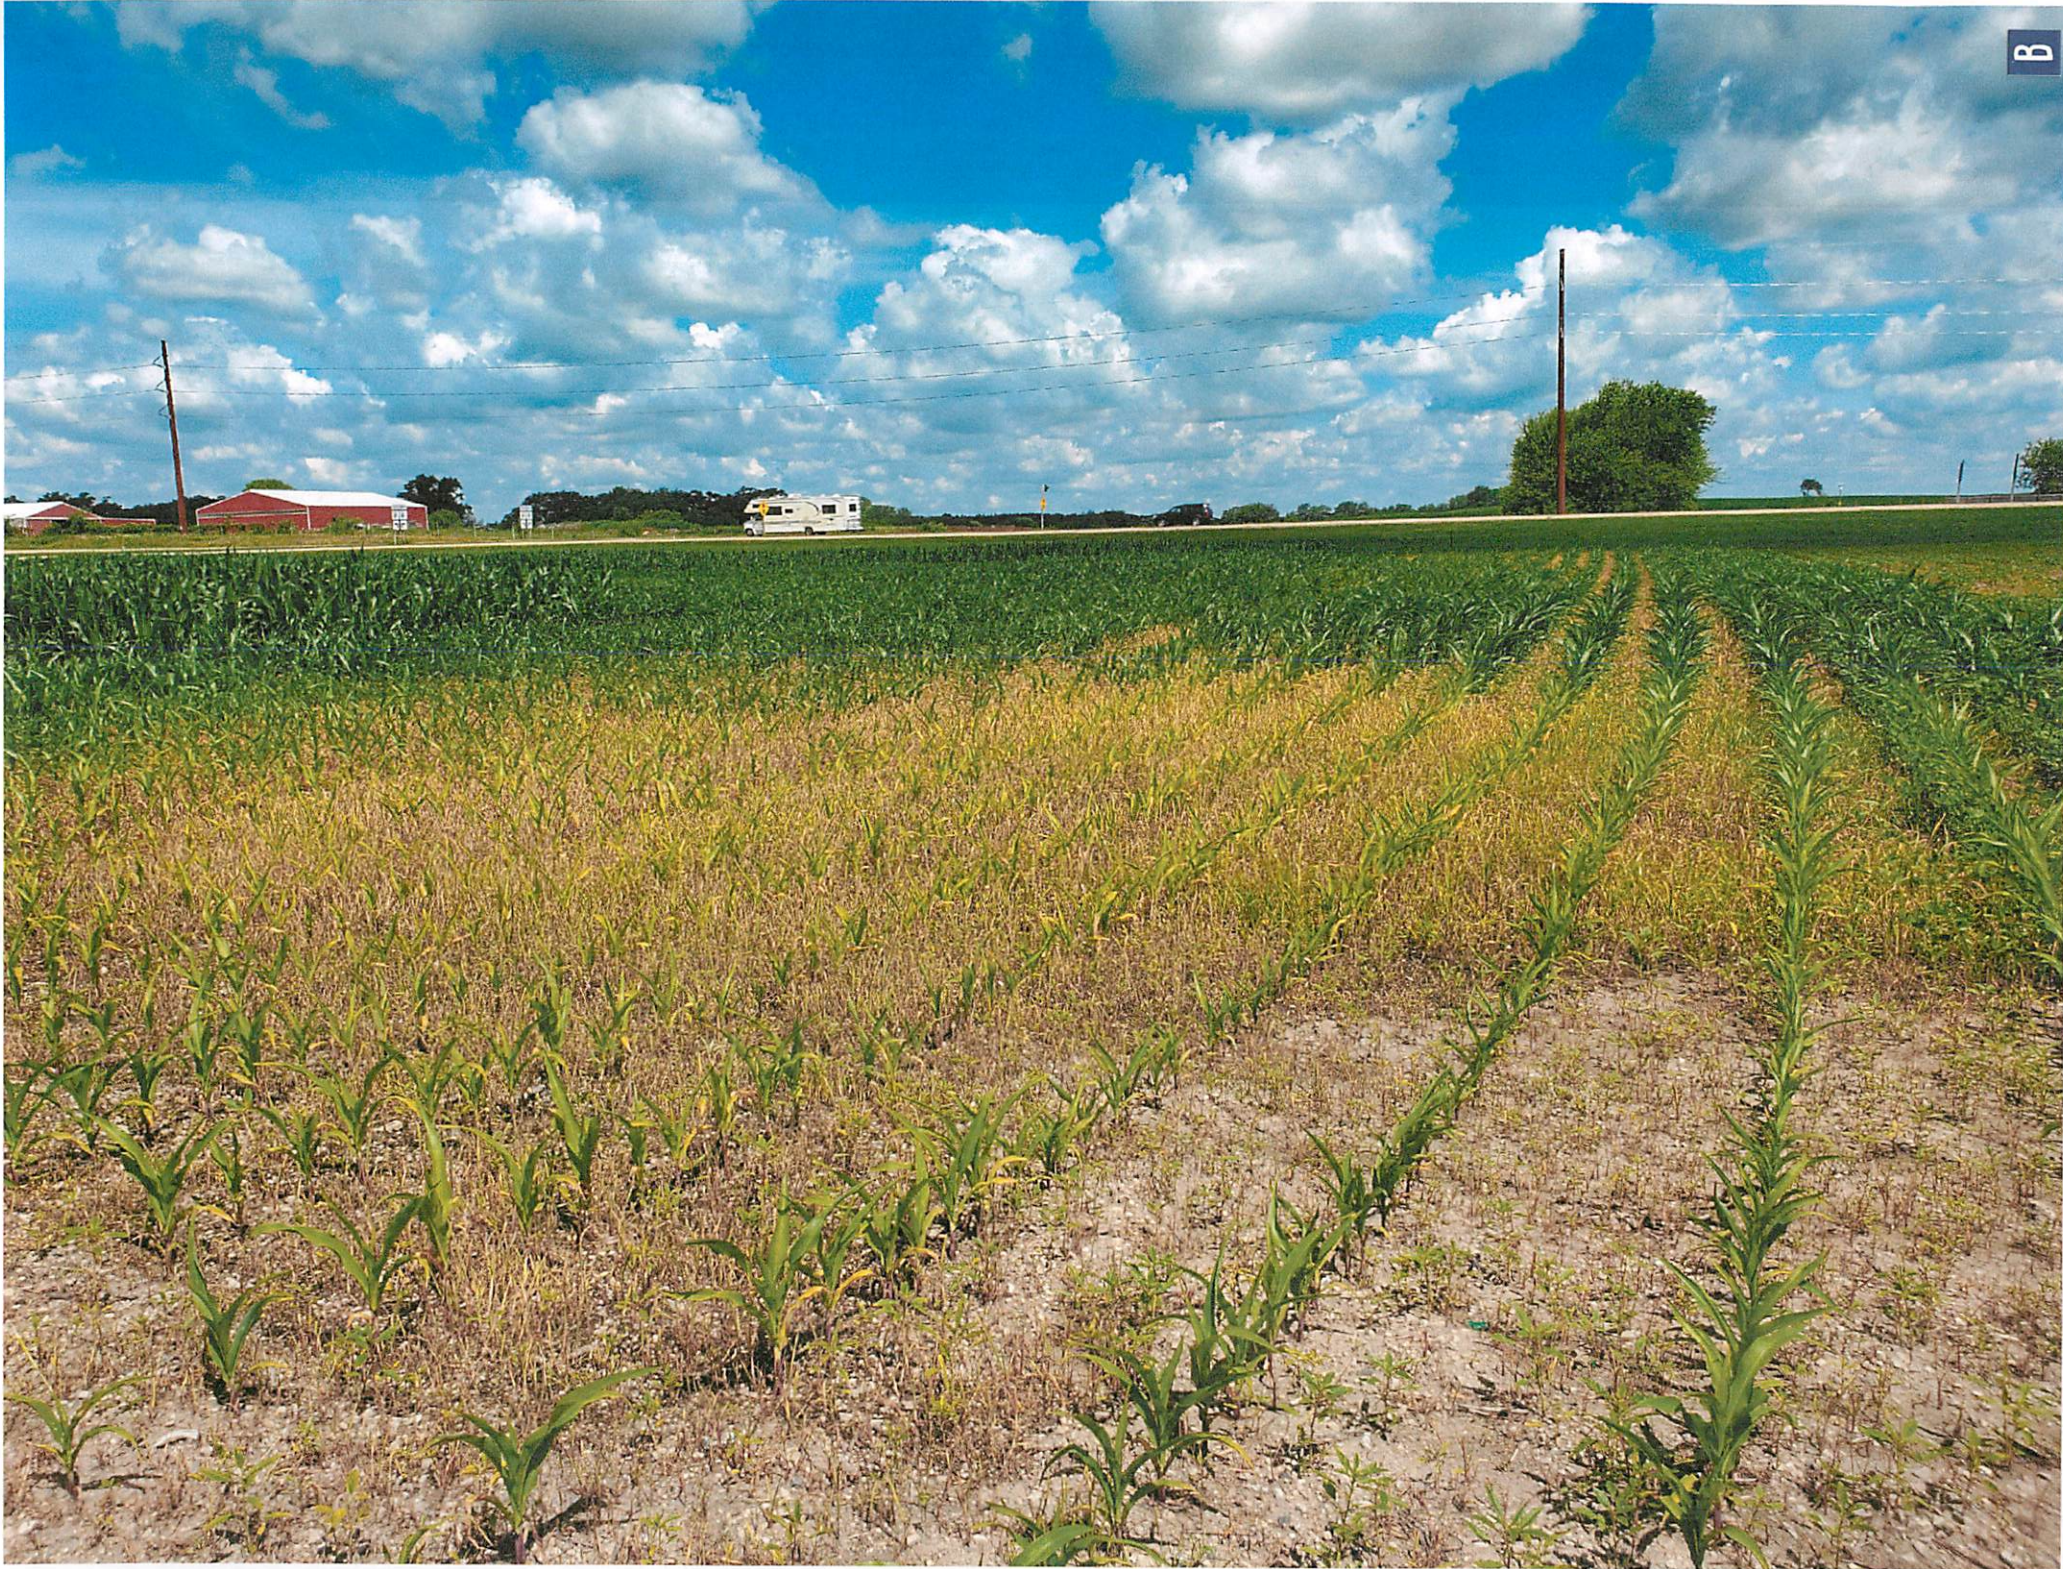
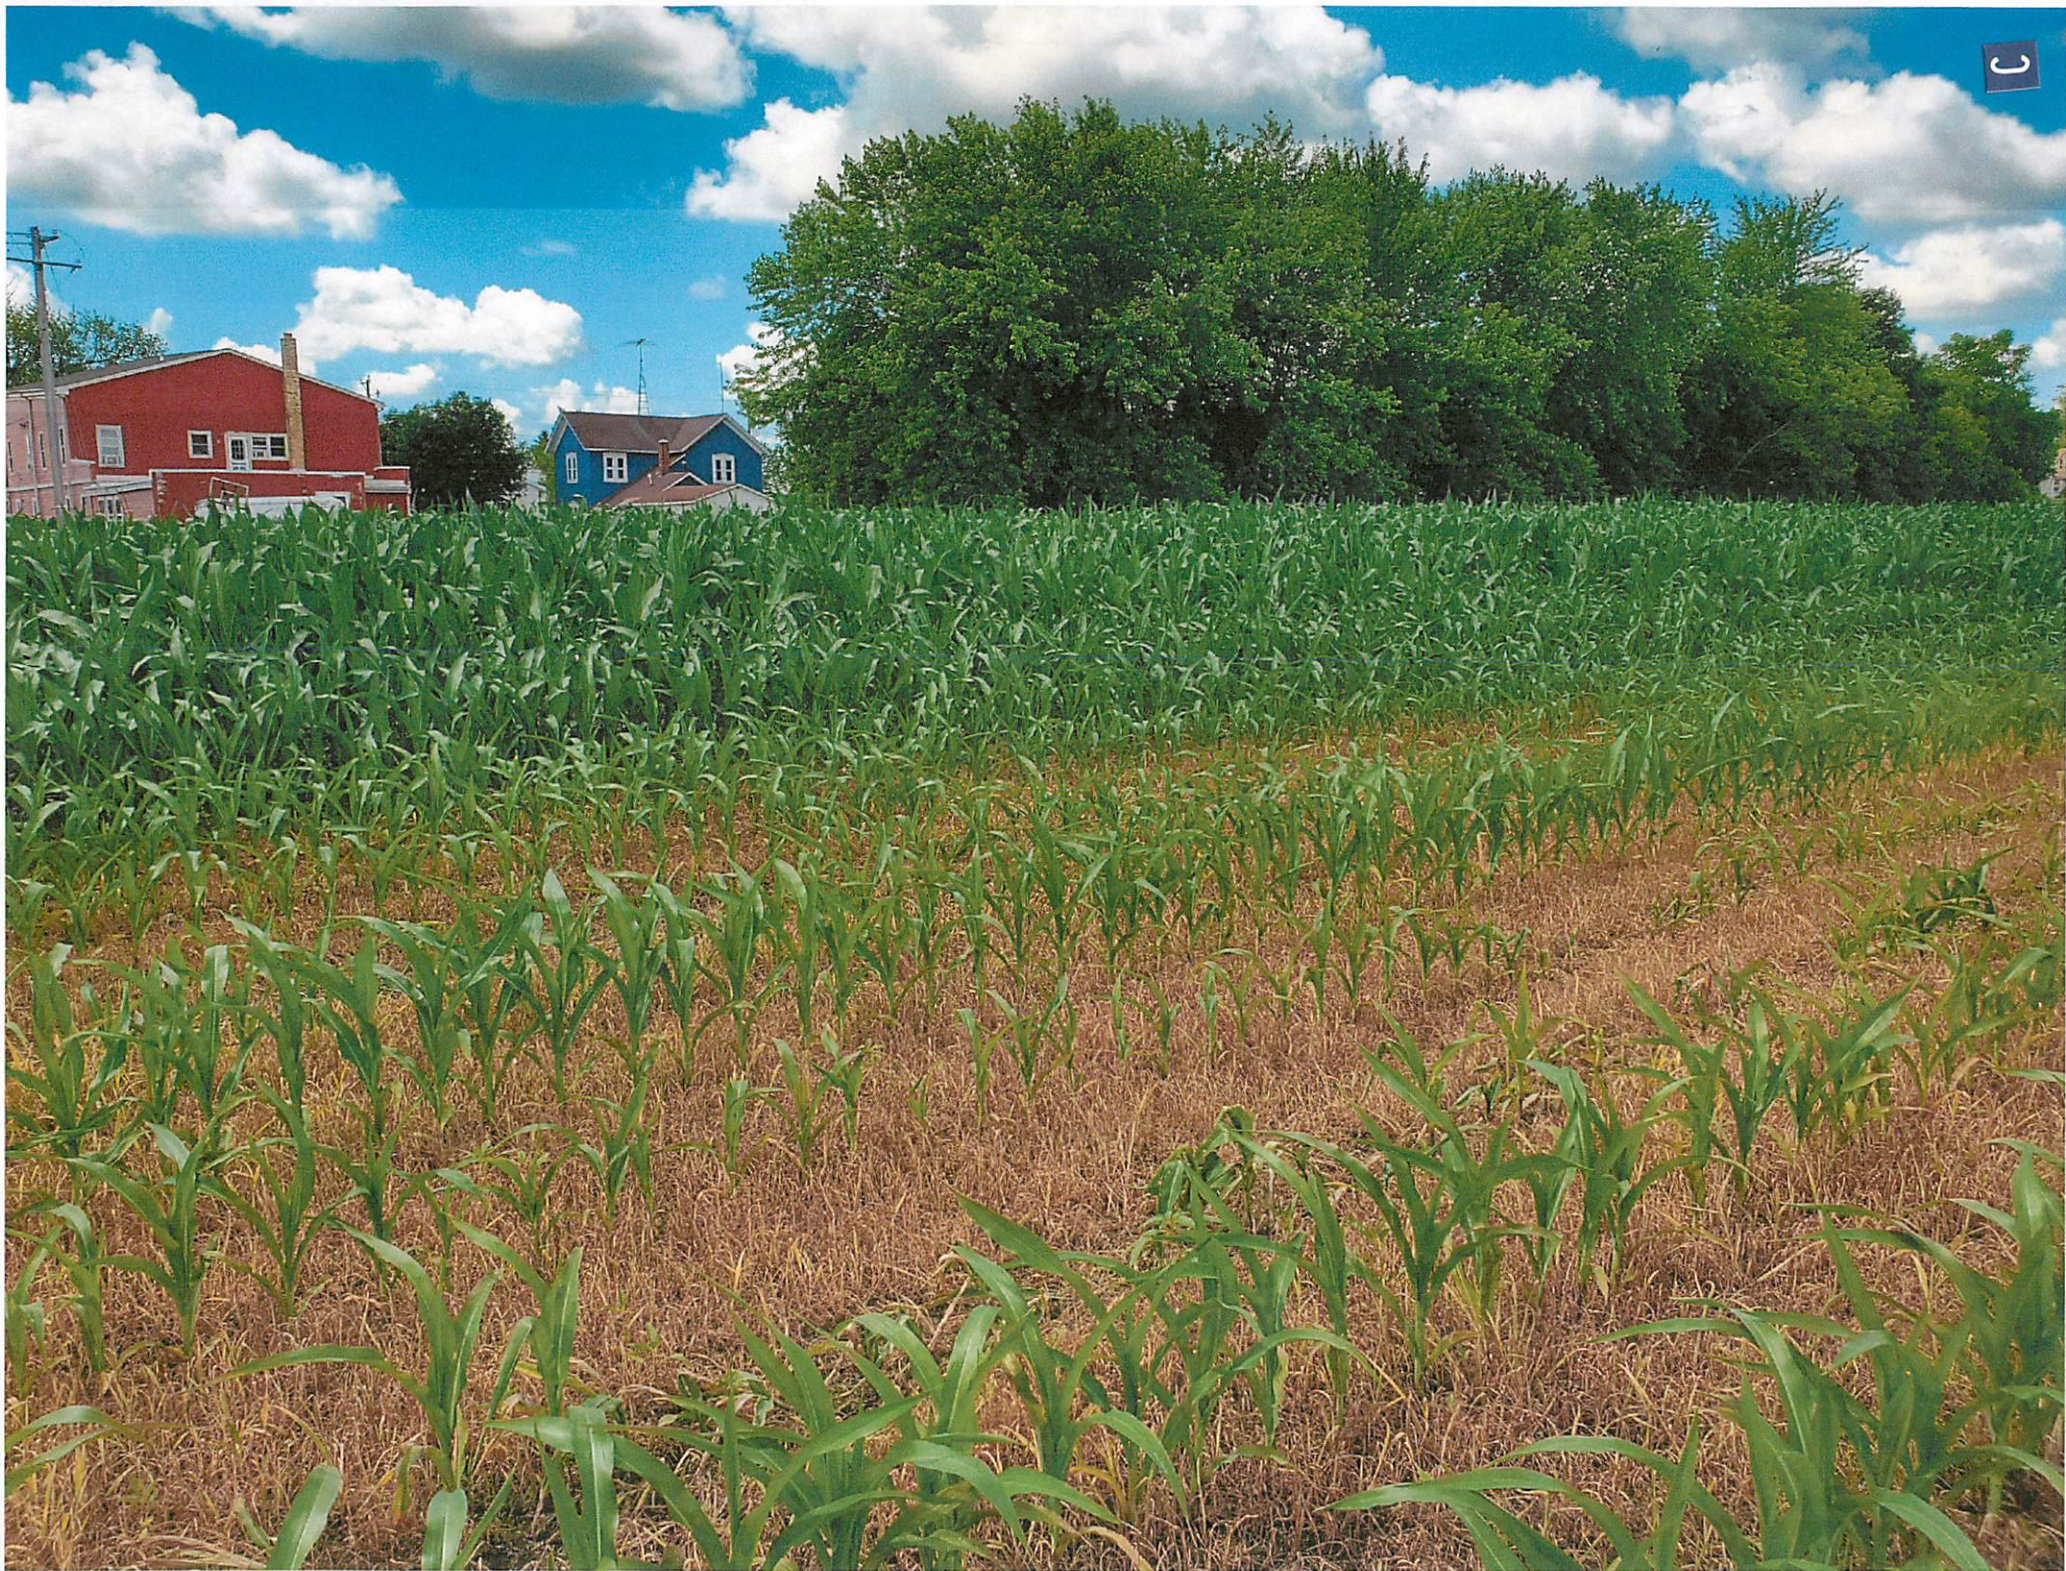
Data point #'s 1, 2, and 3 are located in three separate areas of the field that displayed stunted corn crops. While the 10 year slide review did not indicate that these conditions would be present, the wetter than normal conditions this spring contributed to the stunted crops in these spots. These three areas are shallow depressional basins. All three are dominated by corn and giant foxtail grass. Soil indicators are not present in any of these areas. Hydrology indicators at all three points are Stunted or Stressed Plants and Geomorphic Position. See Photos A, B, and C.
