# BENEDICT LAKE USE REPORT UPDATE LR-1

Prepared by the  
Southeastern Wisconsin Regional Planning Commission  
for  
Kenosha County, Wisconsin  
October 2017

This Lake Use Report Update is a product of the Lake and Stream Resources Classification Project for Kenosha County Wisconsin: 2017. This report is available online at [co.kenosha.wi.us](http://co.kenosha.wi.us).

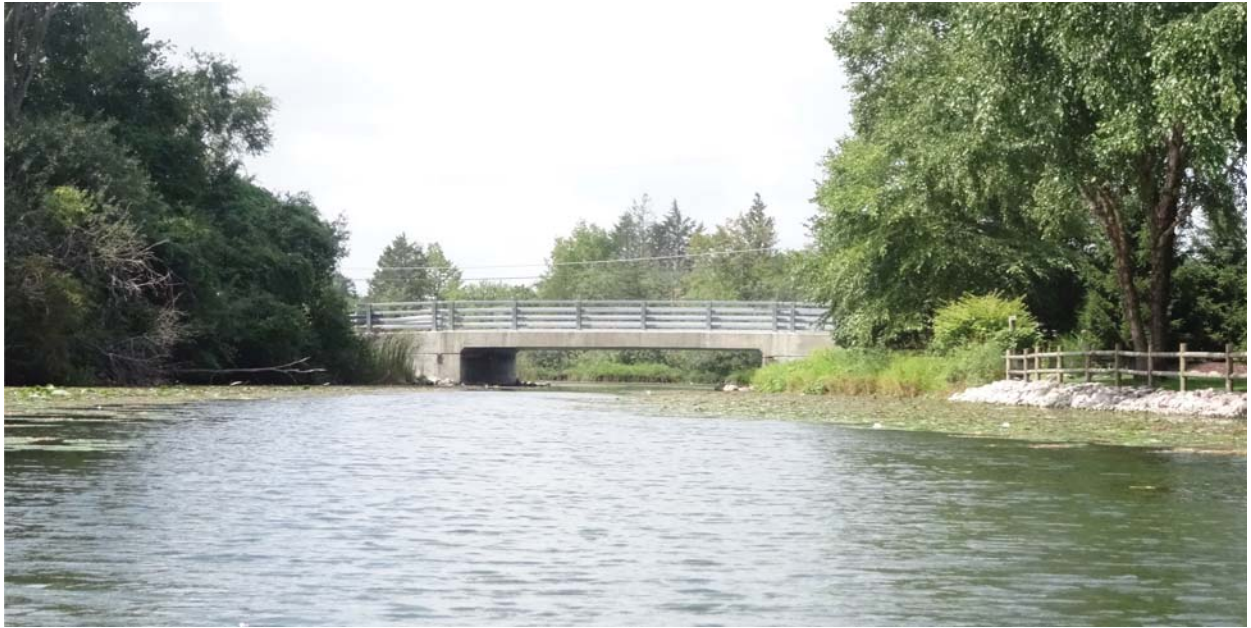
**Figure 1**  
**Benedict Lake Outflow Channel into Tombeau Lake: 2014**  
**(View is from Benedict)**

Water drains from Benedict Lake through the outflow channel into Tombeau Lake (Figure 1). Tombeau Lake drains to Nippersink Creek (East branch) which eventually drains into the Fox River in Illinois. The water levels of both lakes are controlled by a small dam (Figure 2) located on an outlet channel extending southwest from Tombeau Lake.

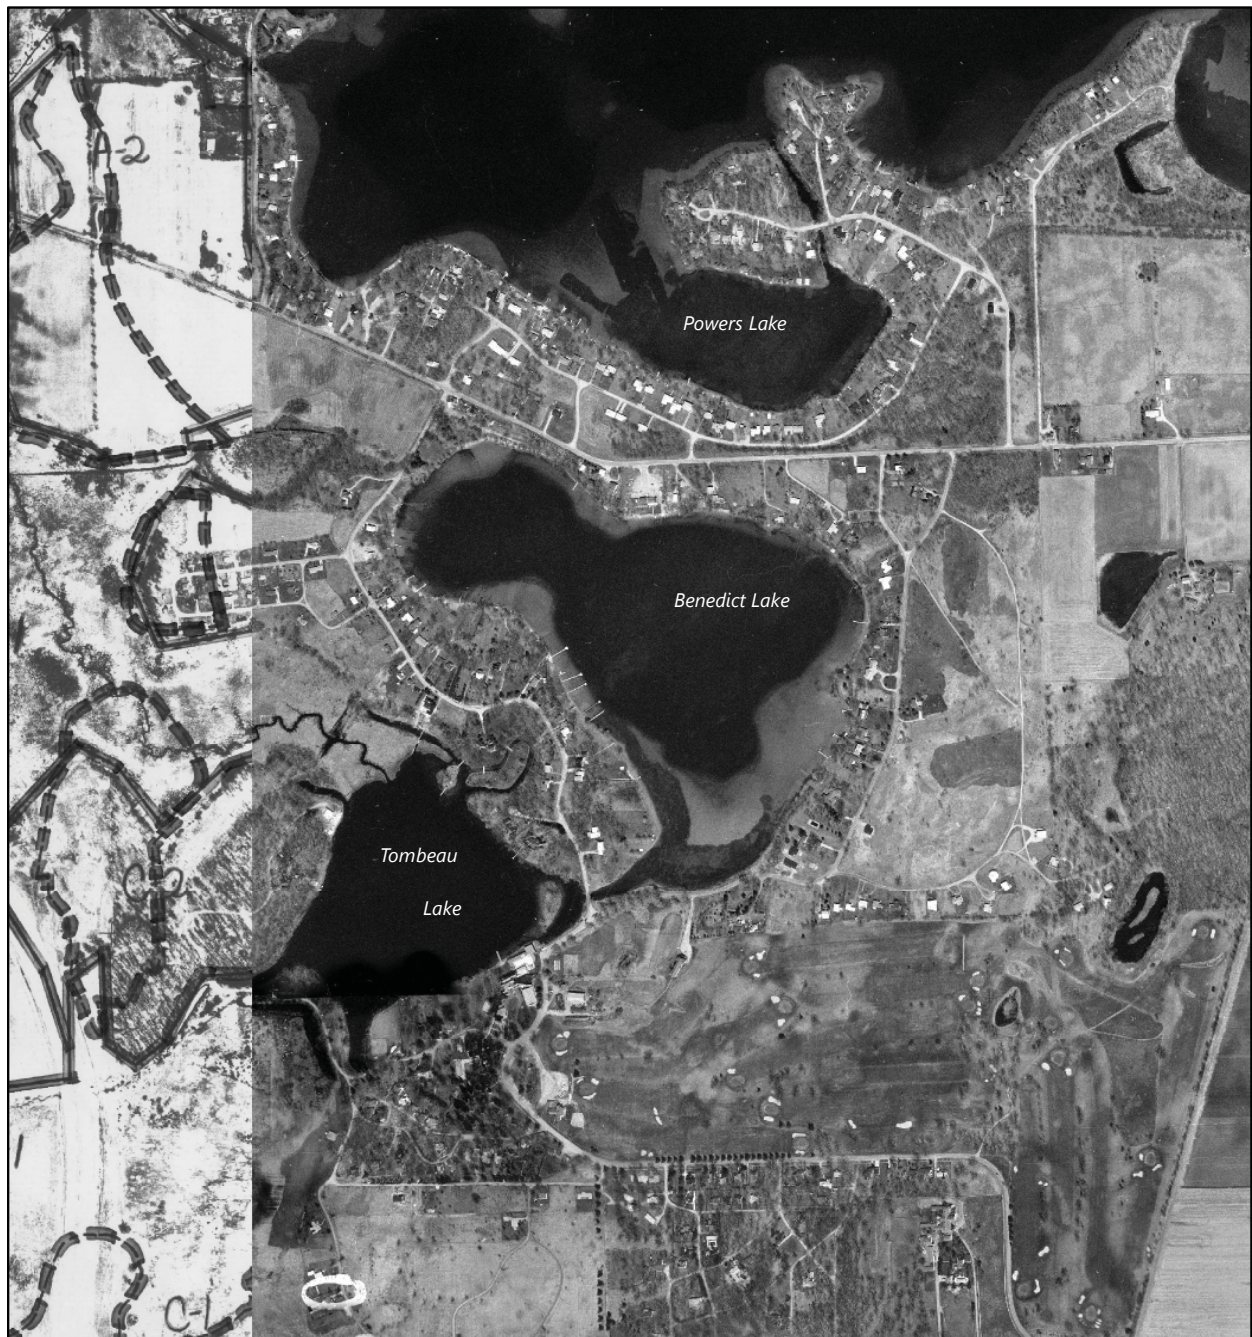
**Figure 3**  
**1970 Aerial Photograph of Benedict Lake**

Significant land development has occurred around Benedict Lake since the writing of the previous lake use report (see Figures 3 and 4). Map 2 and Table 2 show the 2010 land uses in the Benedict Lake watershed. Agricultural lands comprise over 40 percent of all land use, the most between urban and rural use. Wetlands and woodlands comprise another 3 and 5 percent of total land use, respectively. Urban uses account for just over 40 percent of the watershed with low-density single-family residential areas accounting for the majority of residential land use. Projected 2035 land use (Table 2) suggest significant changes within the Benedict Lake watershed. Currently, projections indicate that almost all agricultural lands within the watershed will be converted to residential areas, resulting in an 80 percent decrease in rural lands, and a 100 percent increase in urban lands.

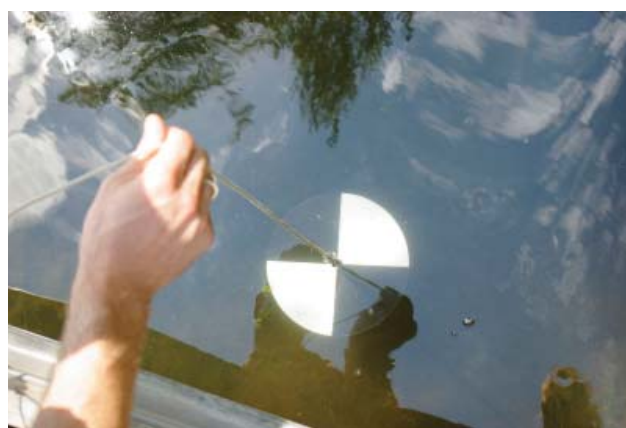
**Figure 5**  
Measuring Water Clarity with a Secchi Disk

Water clarity is a commonly used and easily understood surrogate for perceived water quality. Many people equate "clear" water with "clean" water. While this is not always true, methods have been developed to allow lake water clarity to be compared and contrasted. Water clarity is measured with a Secchi disk (Figure 5). "Secchi depth" is the distance below the water surface that a Secchi disk can be seen under carefully prescribed conditions. Secchi depth has been measured in the Lake between June and August from 1989 through 2014 (Figure 6) and indicates fairly steady water clarity that averages approximately 9 feet. Water

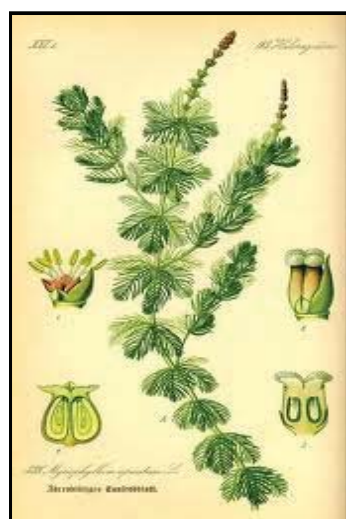
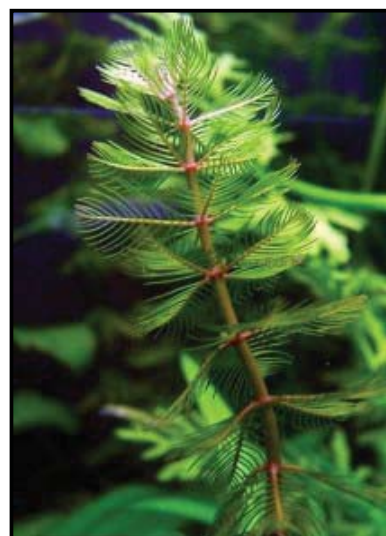
**Figure 8**  
**Eurasian Water Milfoil (*Myriophyllum spicatum*)**

Identifying Features	Ecology
<ul style="list-style-type: none"> <li>• Stems spaghetti-like, often pinkish, growing long with many branches near the water surface</li> <li>• Leaves with 12 to 21 pairs of leaflets</li> <li>• Produces no winter buds (turions)</li> </ul> <p>Eurasian water milfoil is similar to northern water milfoil (<i>M. sibiricum</i>). However, northern water milfoil has five to 12 pairs of leaflets per leaf and stouter white or pale brown stems</p>	<ul style="list-style-type: none"> <li>• Hybridizes with native northern water milfoil, resulting in plants with intermediate characteristics</li> <li>• Invasive, growing quickly, forming canopies, and getting a head-start in spring due to an ability to grow in cool water</li> <li>• Grows from root stalks and stem fragments in both lakes and streams, shallow and deep; tolerates disturbed conditions</li> <li>• Provides some forage to waterfowl, but supports fewer aquatic invertebrates than mixed stands of aquatic vegetation</li> </ul>

EWM, one of eight milfoil species found in Wisconsin, is the only milfoil species known to be exotic/nonnative (see Figure 8). This plant can grow profusely in nutrient-rich lakes impeding boating and recreational use. Because of this management concern, EWM is actively managed by mechanical and chemical means in many Southeastern Wisconsin lakes. In recent years, EWM/native northern milfoil hybrids have been observed in some Wisconsin lakes. These hybrids pose a difficult management problem: not only do hybrids grow quickly like EWM, but hybrids appear to be more tolerant to aquatic herbicides such as 2, 4-D and Endothall
