# **CAMP LAKE USE REPORT UPDATE LR-2**

Prepared by the Southeastern Wisconsin Regional Planning Commission

Kenosha County, Wisconsin October 2017

This Lake Use Report Update is a product of the Lake and Stream Resources Classification Project for Kenosha County Wisconsin: 2017. This report is available online at co.kenosha.wi.us.

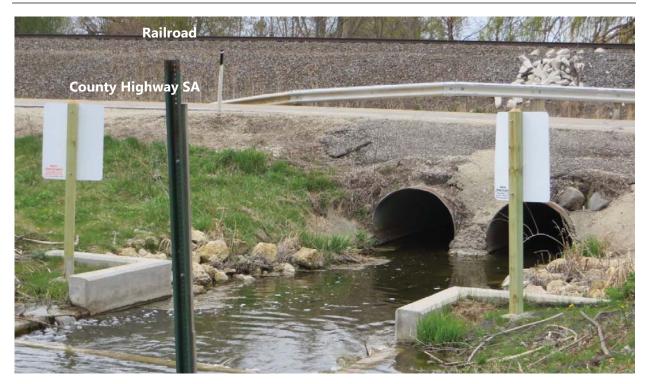
Figure 1
Surface Water Draining From Center Lake to Camp Lake

Note: The outlet dam in the foreground is used to control Center Lake's Elevation. After leaving Center Lake, water passes under County Trunk Highway SA and the Canadian National Railroad before reaching Camp Lake

Several intermittent and perennial tributary streams enter the Lake. Much of the water entering Camp Lake first passes through Center Lake, a separate waterbody lying a short distance to the north of Camp Lake. A low-head dam is located in the channel leading from Center Lake to Camp Lake (Figure 1, Map 1). Flow from Center Lake to Camp Lake may likely be imperceptible during extended dry weather due to the small elevation difference between the Lakes and low flow volume. Some groundwater also discharges to Camp Lake and its tributary streams.

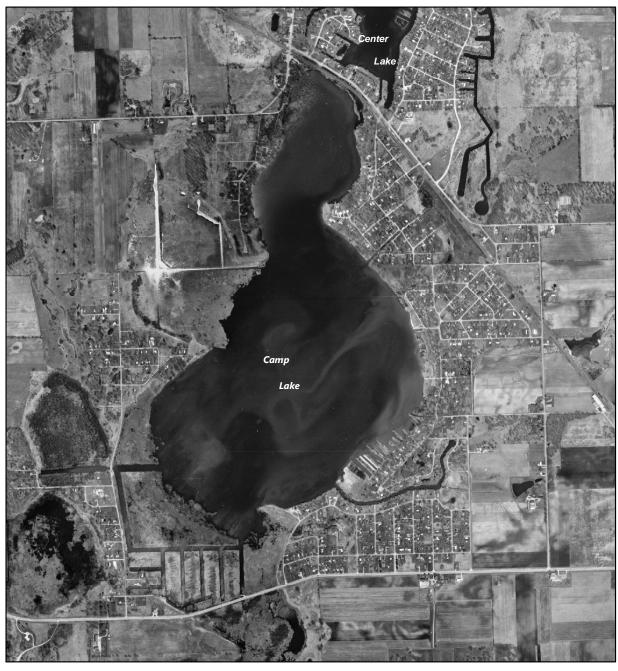
Figure 3 1970 Aerial Photograph of Camp Lake

Date of Photography: 1970

Land use immediately adjacent to Camp Lake has not significantly changed since 1970 (see Figures 3 and 4). Land use as of 2010 in the Camp Lake direct tributary area is illustrated on Map 2 and summarized in Table 2. As of 2010, agricultural lands accounted for over 40 percent of the Lake's direct tributary area land use. Wetlands and woodlands covered another 19 and 5 percent, respectively, of the total direct tributary area. Urban uses accounted for about 27 percent of the Lake's direct tributary area, with residential and transportation/communication/utility land uses accounting for nearly 90 percent of the urban land use total. Planned 2035 land use (Table 2) suggests significant changes within the Camp Lake direct tributary area. The forecast suggests that essentially all agricultural lands within the Lake's direct tributary area will be converted to residential use, resulting in a 56 percent decrease in rural land use and a 154 percent increase in urban land use. Low-density residential and industrial uses account for most of the planned increase in urban land use.

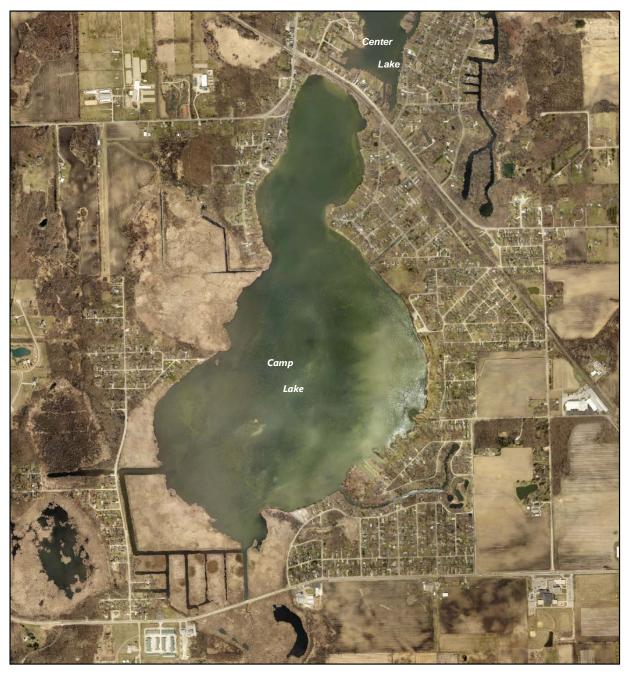
Figure 4
2015 Orthophotograph of Camp Lake

Date of Photography: 2015
