# **HOOKER LAKE USE REPORT UPDATE LR-5**

Prepared by the Southeastern Wisconsin Regional Planning Commission

Kenosha County, Wisconsin October 2017

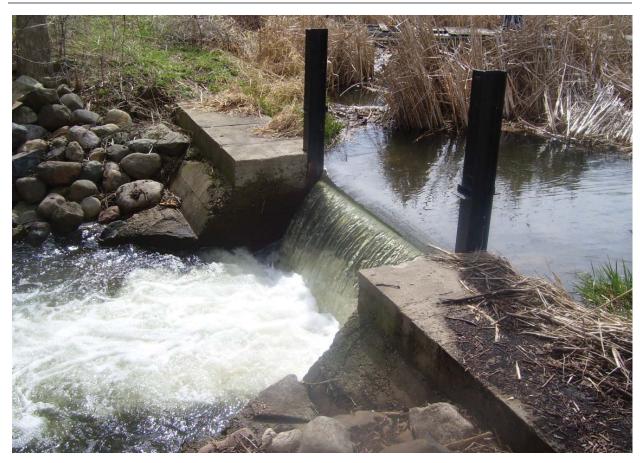
Figure 1 Hooker Lake Outlet

the shoreline of the eastern-most area of Hooker Lake proper, and is generally referred to as "Hooker Lake Dam." At present, this dam is not known to be used and is largely submerged. Water levels within the Lake are now controlled by the "Bryzek Dam" located approximately 1,100 feet east-northeast of the Hooker Lake Dam, downstream of the shallow lake (Figure 1).

Water drains from Hooker Lake through a small shallow lake into the Salem Branch of Brighton Creek and eventually into the Des Plaines River. The outflow of Hooker Lake has been controlled by a dam since at least 1929.9 At least 3 dams have controlled the Lake's water level over this period. The most upstream dam is located along

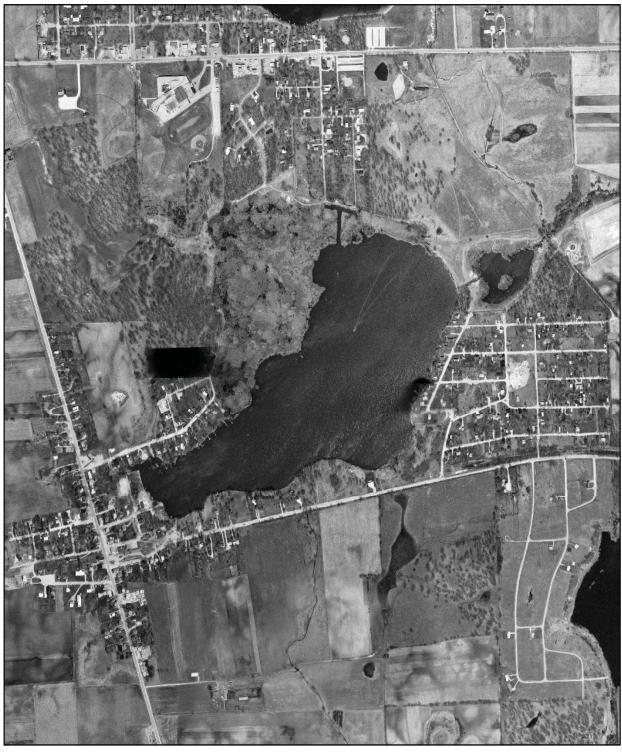
Figure 2 1970 Aerial Photograph of Hooker Lake

Date of Photography: 1970

Some land development has occurred around Hooker Lake since 1970 (see Figures 2 and 3). Map 2 and Table 2 show the 2010 land uses in the Hooker Lake watershed. Agricultural lands comprise over 40 percent of watershed land use. Wetlands and woodlands comprise another 11 and 10 percent of watershed land use, respectively. Urban uses account for just over 30 percent of the watershed with medium-density single-family residential areas accounting for the majority of residential land use. Residential land uses, particularly on the north and south sides of the Lake, visibly increased between 1970 and 2015 (See Figures 2 and 3). Projected 2035 land use (Table 2) indicates significant changes within the Hooker Lake watershed. Currently, projections indicate that almost all agricultural lands within the watershed will be converted to residential areas, resulting in a 60 percent decrease in rural lands and a 130 percent increase in urban lands.
