LILLY LAKE USE REPORT UPDATE LR-6

Prepared by the Southeastern Wisconsin Regional Planning Commission for Kenosha County, Wisconsin October 2017

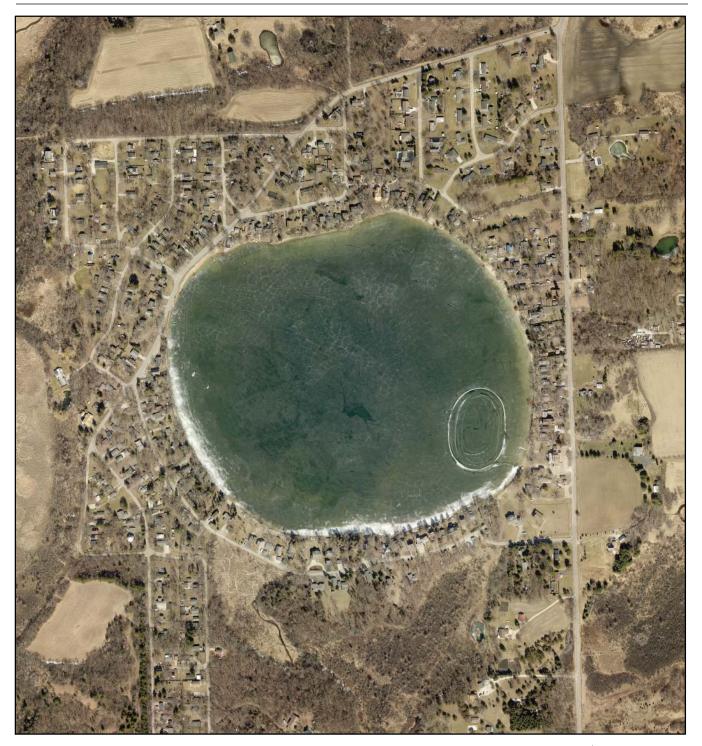
Figure 2 2015 Orthophotograph of Lilly Lake

Date of Photography: 2015

Moderate land development has occurred around Lilly Lake since of the previous lake use report was issued (see Figures 1 and 2). Map 2 and Table 2 show the 2010 land uses in the Lilly Lake watershed. Urban uses occupy over 95 percent of the watershed with medium-density, single-family residential areas accounting for nearly 80 percent of land use. Open lands are the largest rural land use and comprise approximately

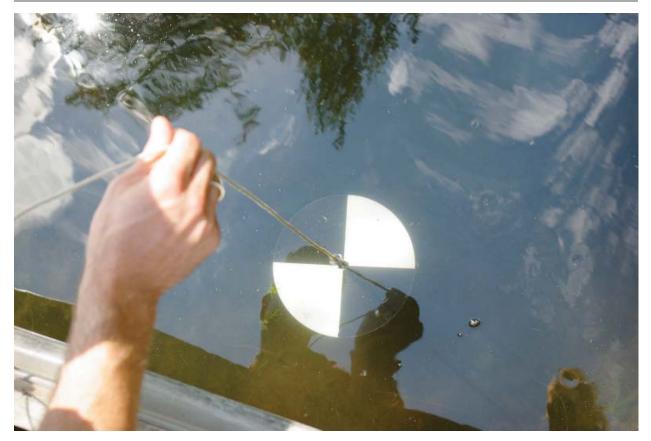
Water clarity is a commonly used and easily understood surrogate for perceived water quality. Many people equate "clear" water with "clean" water. While this is not always true, methods have been developed to allow lake water clarity to be compared and contrasted. Water clarity is measured with a Secchi disk (Figure 3). "Secchi depth" is the distance below the water surface that a Secchi disk can be seen under carefully prescribed conditions. Secchi depth has been occasionally measured in the Lake and the results over time are summarized graphically in Figure 4. On average, water clarity has been very good, with Secchi depth readings averaging around 12 feet. Water clarity has also been estimated from satellite imagery,¹⁵ averaging 9.2 feet in 2016, which generally agrees with values actually measured on the Lake. Based upon the available information, Lilly Lake's water clarity is good to very good and has not changed significantly since monitoring began.
