ROCK LAKE USE REPORT UPDATE LR-9

Prepared by the
Southeastern Wisconsin Regional Planning Commission
for
Kenosha County, Wisconsin
October 2017

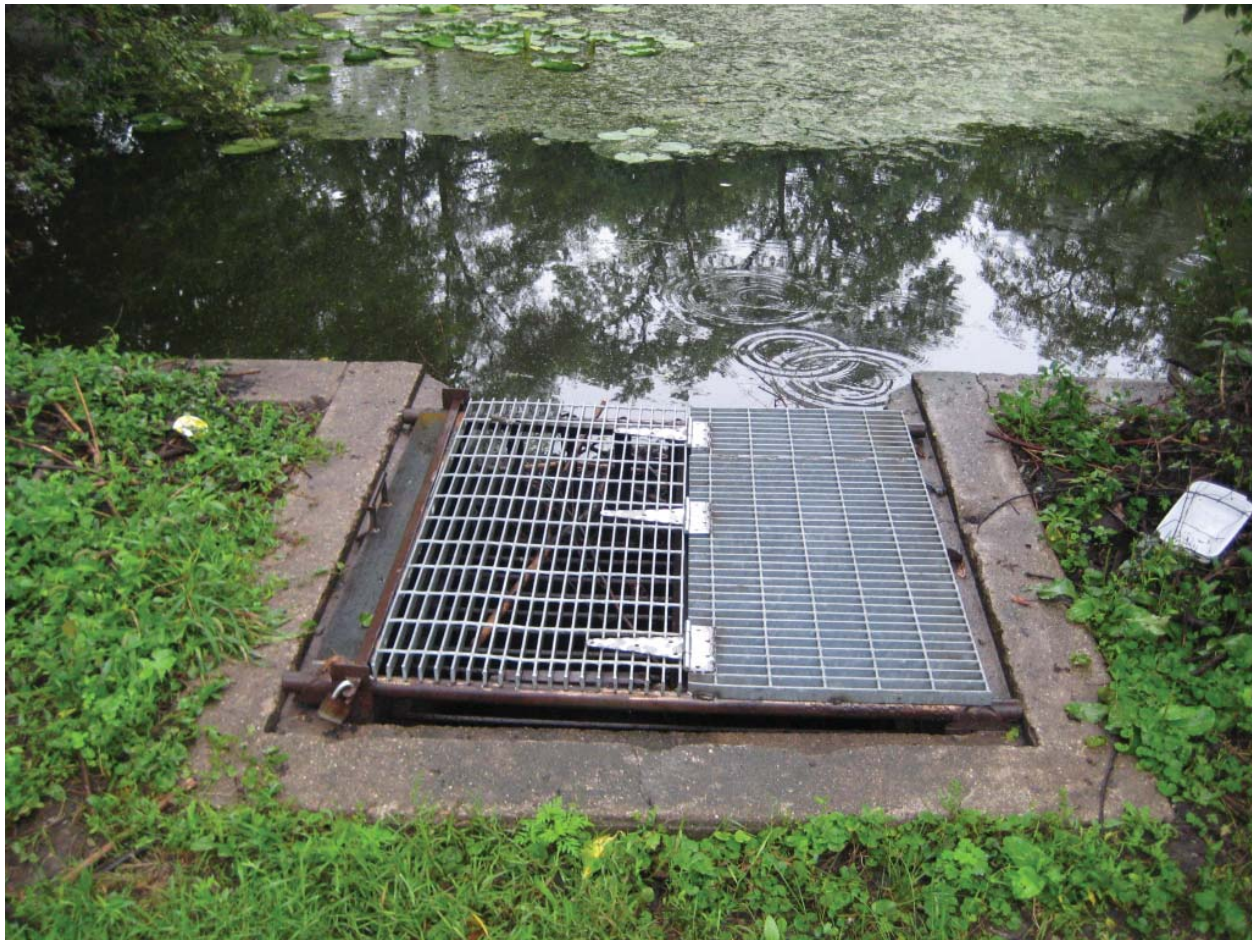
Figure 1
Spillway at Rock Lake

Although the Lake has no true inlet or continuously flowing inflow stream, an intermittent stream enters the Lake on the southeast shore. The Lake's levels are maintained by a spillway located on the outlet channel (Figure 1). Rock Lake forms part of a network of waterbodies that drain to Trevor Creek, a tributary to the Fox River.

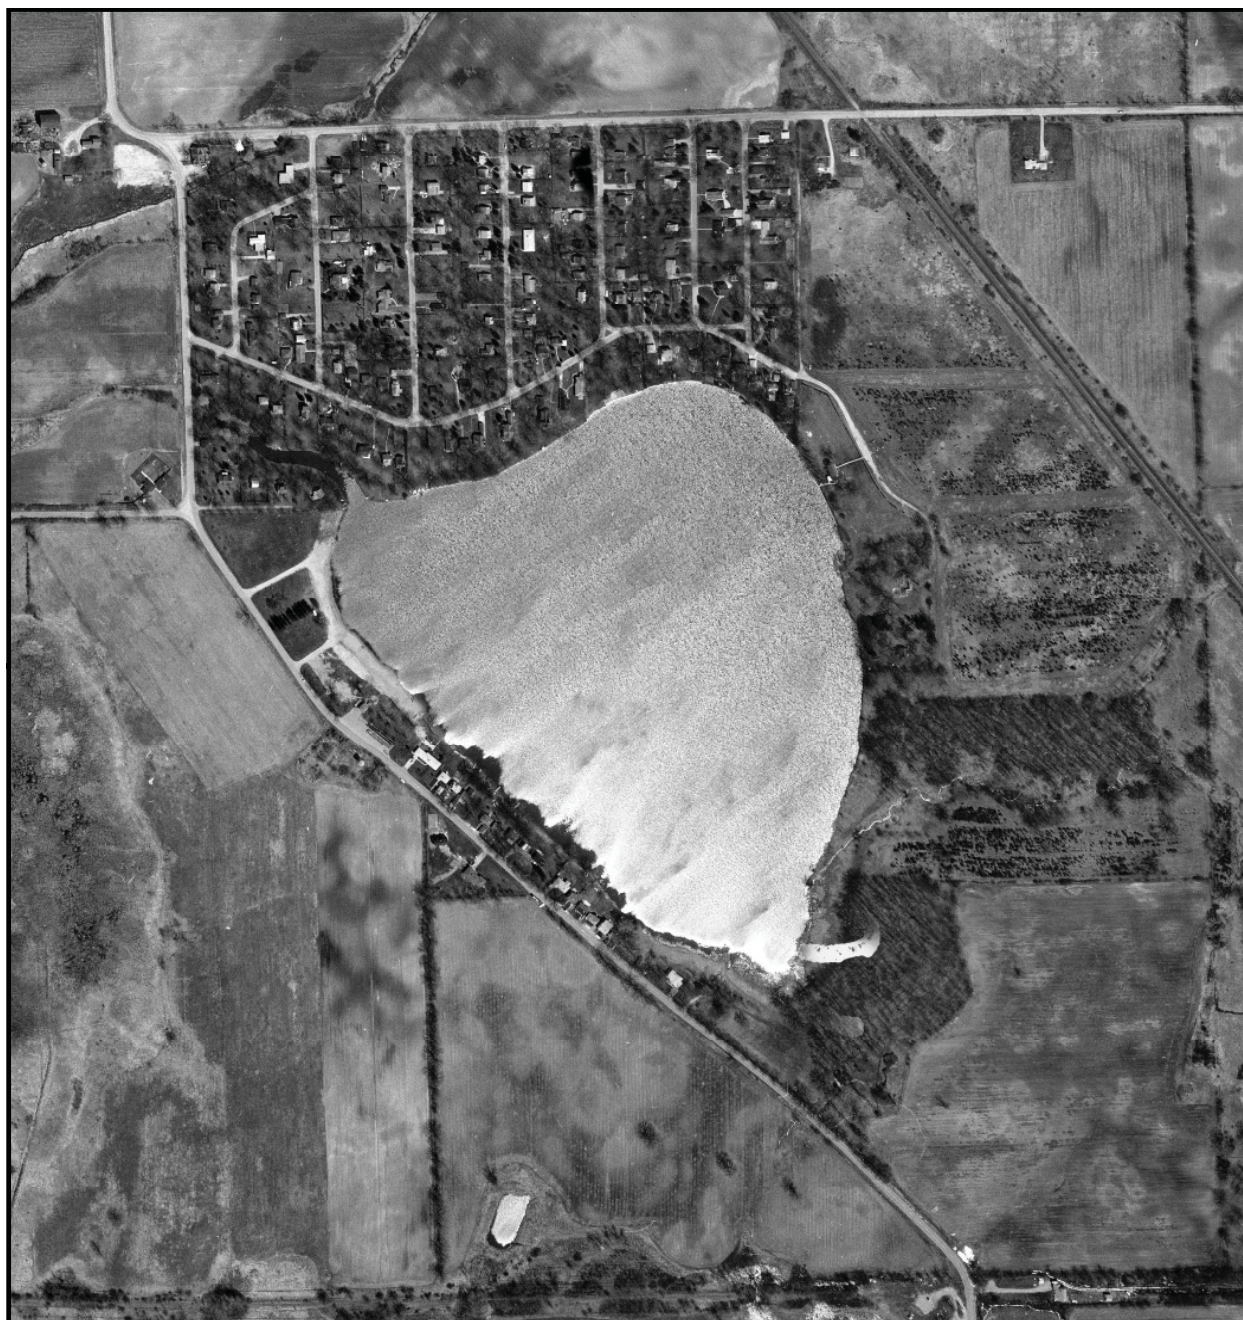
Figure 2
1970 Aerial Photograph of Rock Lake

Significant land development occurred around Rock Lake between 1970 and 2015 (see Figures 2 and 3). Map 2 and Table 2 show the 2010 land uses in the Rock Lake watershed. Agricultural and other open lands comprise approximately 45 percent of watershed land use. Wetlands and woodlands comprise another 9 and 2 percent of watershed land use, respectively. Urban uses account for approximately 44 percent of the watershed with low- and medium-density single-family residential areas accounting for the majority of residential land use. Projected 2035 land use (Table 3) indicates significant changes within the Rock Lake watershed. Currently, projections indicate that a majority of the agricultural and other open lands within the watershed will be converted to residential and recreational areas, resulting in a 43 percent decrease in rural lands, and a 54 percent increase in urban lands.

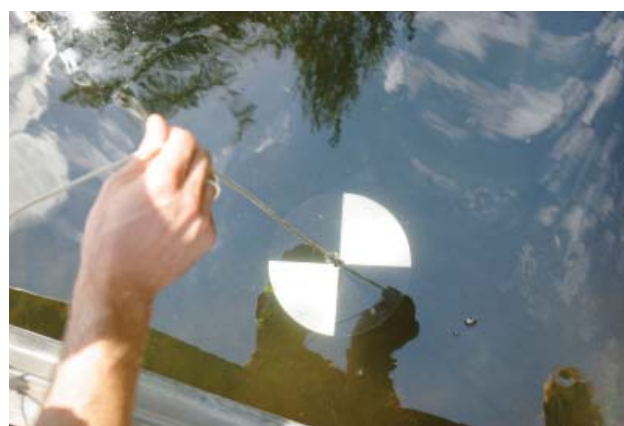
Figure 4
Measuring Water Clarity with a Secchi Disk

Water clarity is a commonly used and easily understood surrogate for perceived water quality. Many people equate "clear" water with "clean" water. While this is not always true, methods have been developed to allow lake water clarity to be compared and contrasted. Water clarity is measured with a Secchi disk (Figure 4). "Secchi depth" is the distance below the water surface that a Secchi disk can be seen under carefully prescribed conditions. Water clarity, measured with a Secchi disk during the months of June and August 2014 (Figure 5), show water clarity can be almost 12 feet in the beginning of the summer and decreases

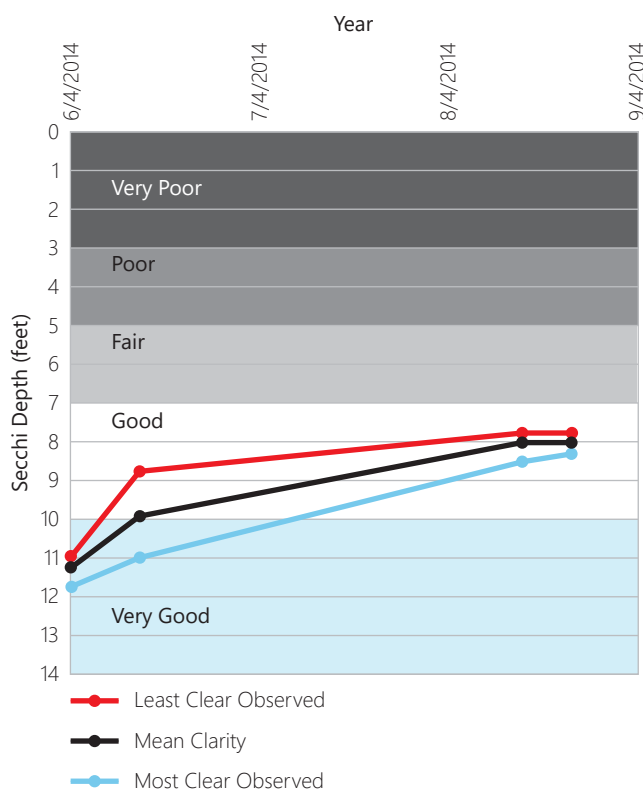
Figure 5
Secchi Disk Measurements for Rock Lake: 2014

to approximately 8 feet by the end of August, corresponding to a Tropic State Index of 45. In addition, WDNR satellite data collected between 2001 and 2017 show an average water clarity of 7.9 feet which is equivalent to a Trophic State Index of 47, and indicates that the Lake is mesotrophic (Table 4).

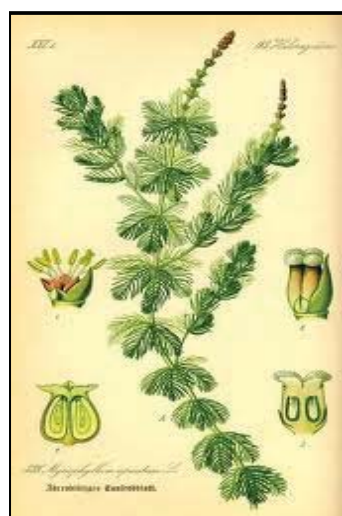
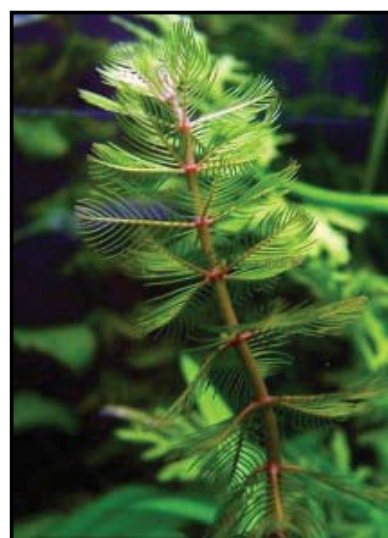
Figure 6
Eurasian Water Milfoil (*Myriophyllum spicatum*)

Identifying Features	Ecology
<ul style="list-style-type: none"> • Stems spaghetti-like, often pinkish, growing long with many branches near the water surface • Leaves with 12 to 21 pairs of leaflets • Produces no winter buds (turions) <p>Eurasian water milfoil is similar to northern water milfoil (<i>M. sibiricum</i>). However, northern water milfoil has five to 12 pairs of leaflets per leaf and stouter white or pale brown stems</p>	<ul style="list-style-type: none"> • Hybridizes with native northern water milfoil, resulting in plants with intermediate characteristics • Invasive, growing quickly, forming canopies, and getting a head-start in spring due to an ability to grow in cool water • Grows from root stalks and stem fragments in both lakes and streams, shallow and deep; tolerates disturbed conditions • Provides some forage to waterfowl, but supports fewer aquatic invertebrates than mixed stands of aquatic vegetation

EWM, one of eight milfoil species found in Wisconsin, is the only milfoil species known to be exotic/nonnative (see Figure 6). This plant can grow profusely in nutrient-rich lakes impeding boating and recreational use. Because of this management concern, EWM is actively managed by mechanical and chemical means in many Southeastern Wisconsin lakes. Eurasian water milfoil was observed during both the 2004 and 2012 surveys. However, the overall dominance of Eurasian water milfoil has not significantly changed from the 2004 survey. Currently, Rock Lake actively manages its aquatic plant population through chemical and mechanical means.

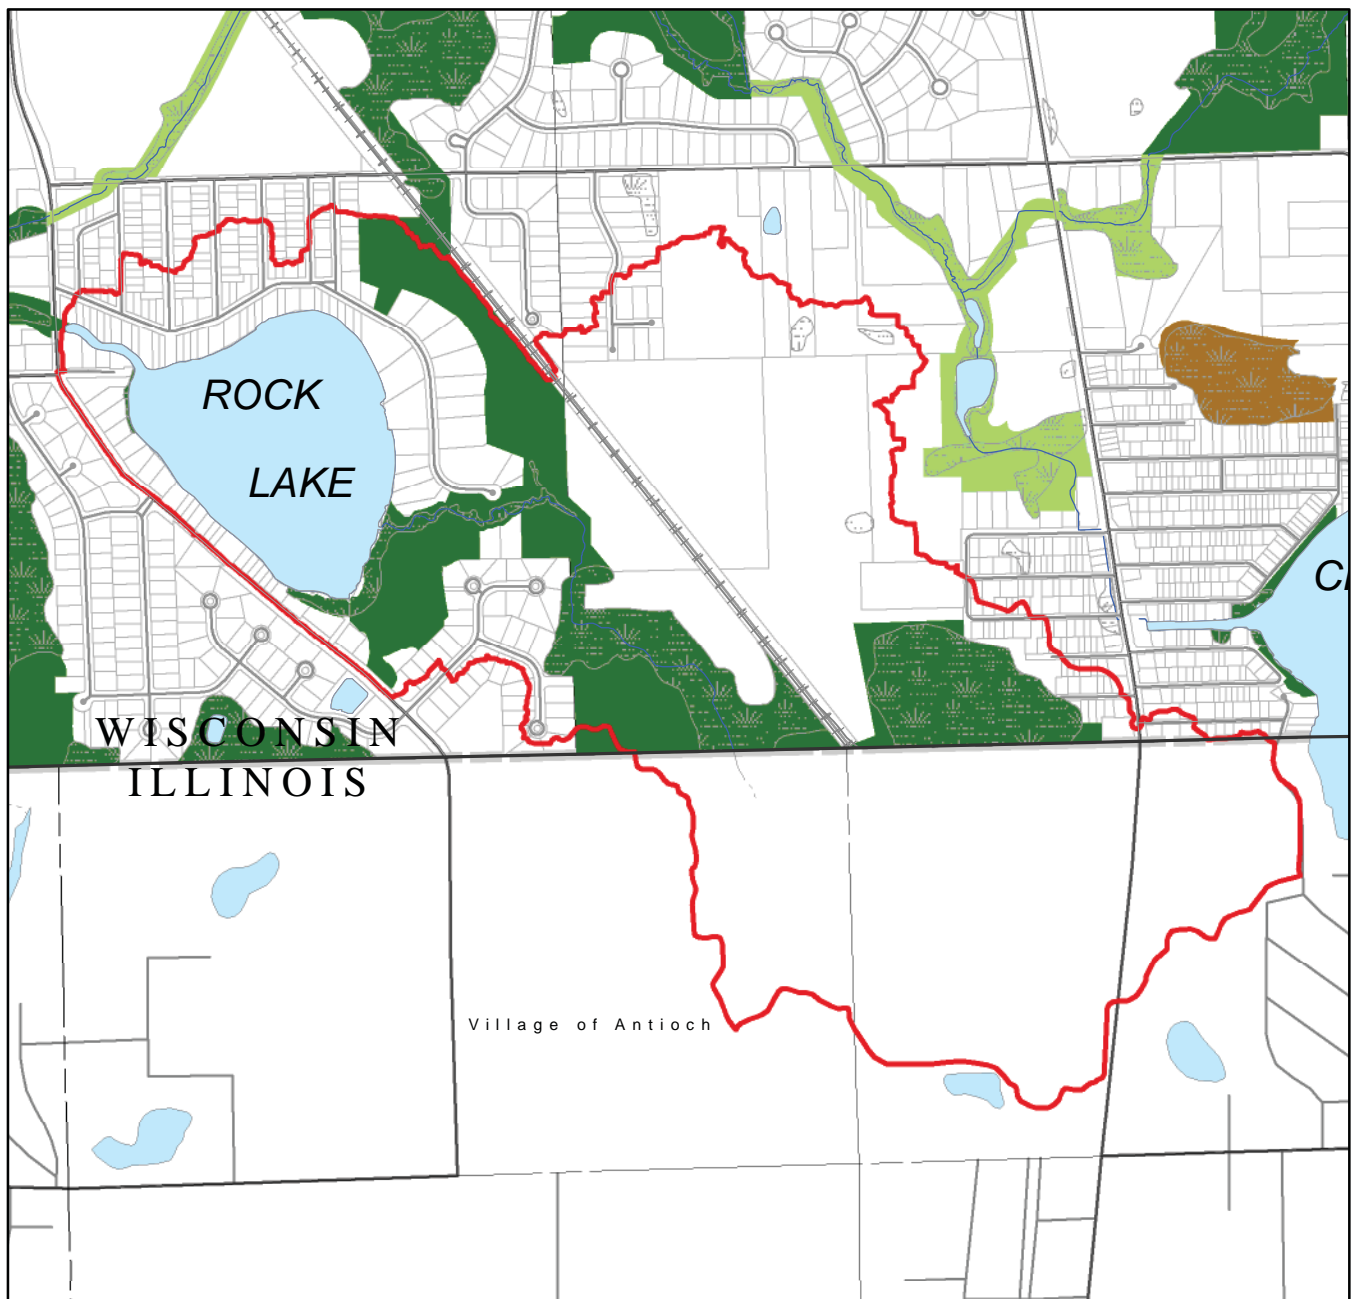
Map 3
Environmentally Significant Areas Within the Rock Lake Watershed: 2015

As shown on Map 3, primary environmental corridor areas occupy nearly 144 acres of land and water area (including the Lake itself) in the Lake's watershed area, much of it in close proximity to the Lake. Preserving these areas is critically important to maintaining the ecological integrity of the Lake.
