VOLTZ LAKE USE REPORT UPDATE LR-12

Prepared by the
Southeastern Wisconsin Regional Planning Commission
for
Kenosha County, Wisconsin
October 2017

This Lake Use Report Update is a product of the Lake and Stream Resources Classification Project for Kenosha County Wisconsin: 2017. This report is available online at co.kenosha.wi.us.

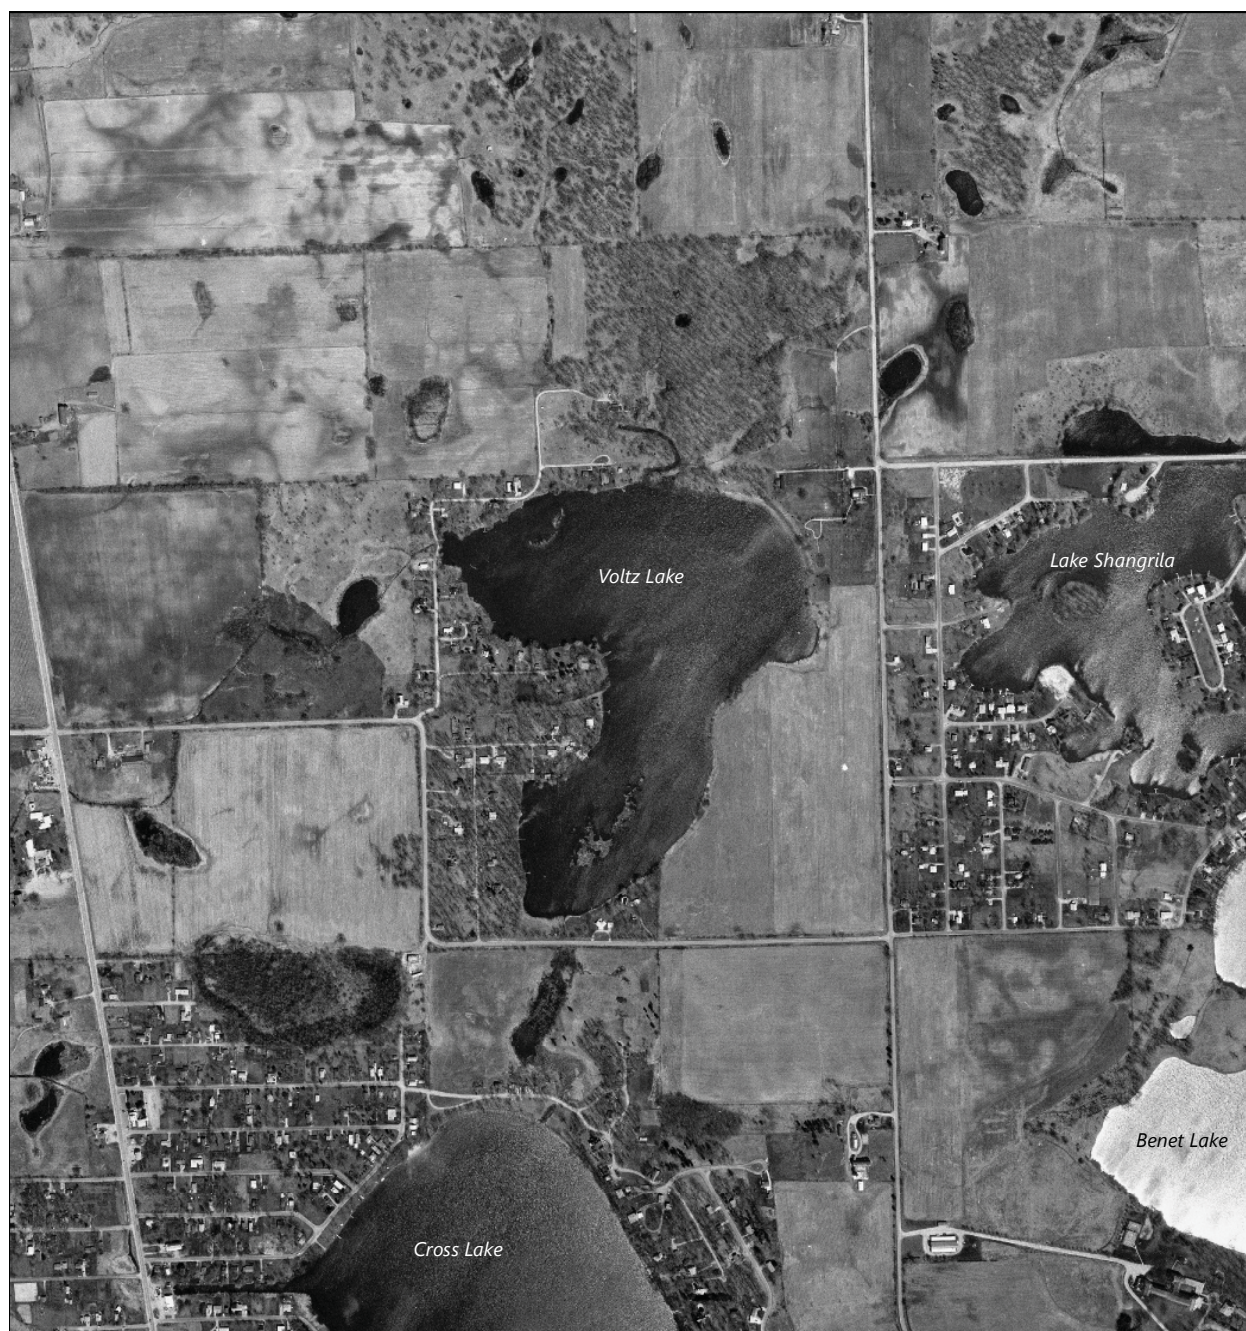
Figure 1
1970 Aerial Photograph of Voltz Lake

Date of Photography: 1970

Significant land development has occurred around Voltz since the writing of the previous lake use report (see Figures 1 and 2). Map 2 and Table 2 show the 2010 land uses in the Voltz Lake watershed. In 2010, rural uses accounted for approximately 78 percent of total land uses and urban uses accounted for about 22 percent. The largest rural land use was agriculture (46 percent), with woodlands and wetlands accounting for 21 and 9 percent of total land use, respectively. The largest urban land use was low-density, single-family residential areas at almost 10 percent.

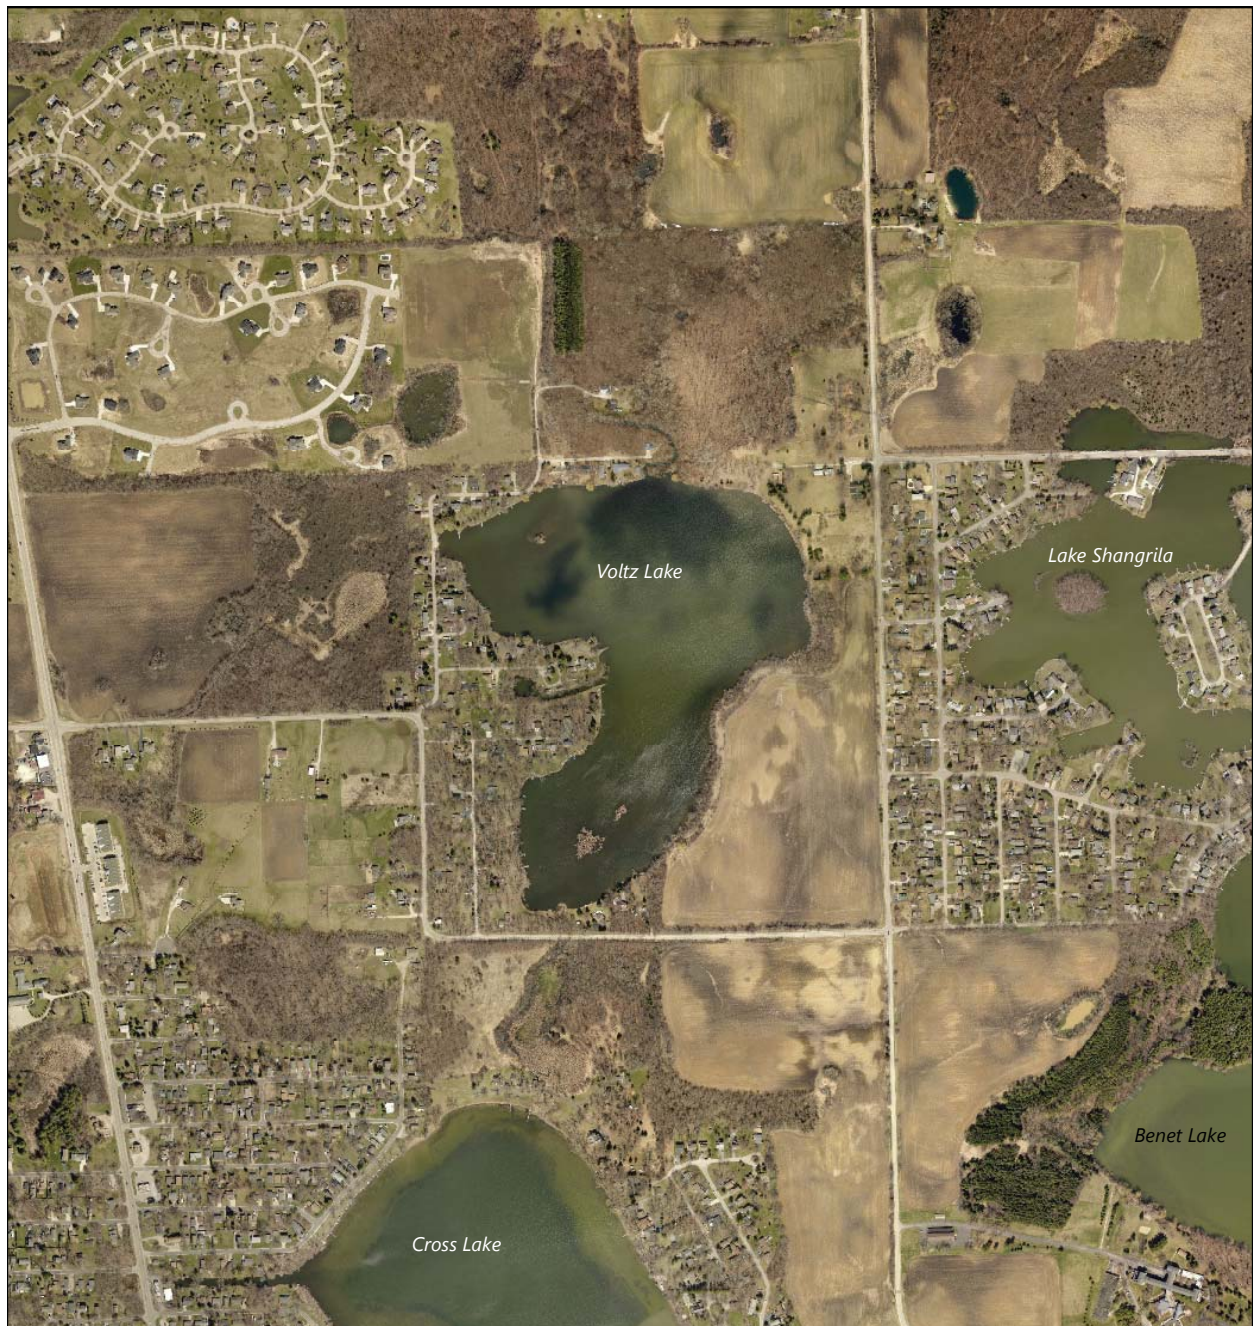
Figure 2
2015 Orthophotograph of Voltz Lake

Date of Photography: 2015

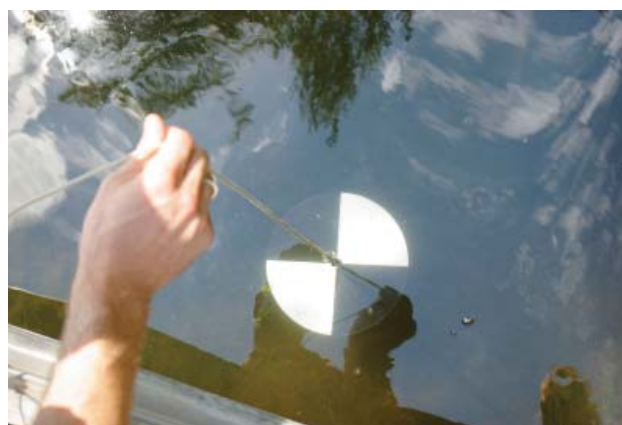
Figure 3
Measuring Water Clarity with a Secchi Disk

Water clarity is a commonly used and easily understood surrogate for perceived water quality. Many people equate "clear" water with "clean" water. While this is not always true, methods have been developed to allow lake water clarity to be compared and contrasted. Water clarity is measured with a Secchi disk (Figure 3). "Secchi depth" is the distance below the water surface that a Secchi disk can be seen under carefully prescribed conditions. Secchi depth has been only occasionally measured in the Lake and the results are summarized graphically in Figure 4. On average, water clarity has been rather poor, with Secchi depth readings during summer 1989 averaging 4.1 feet, indicative of poor water quality.¹⁵ At the time of the original Lake Use Report, the clarity of Voltz Lake was not measured. Secchi depth values reported in 1977

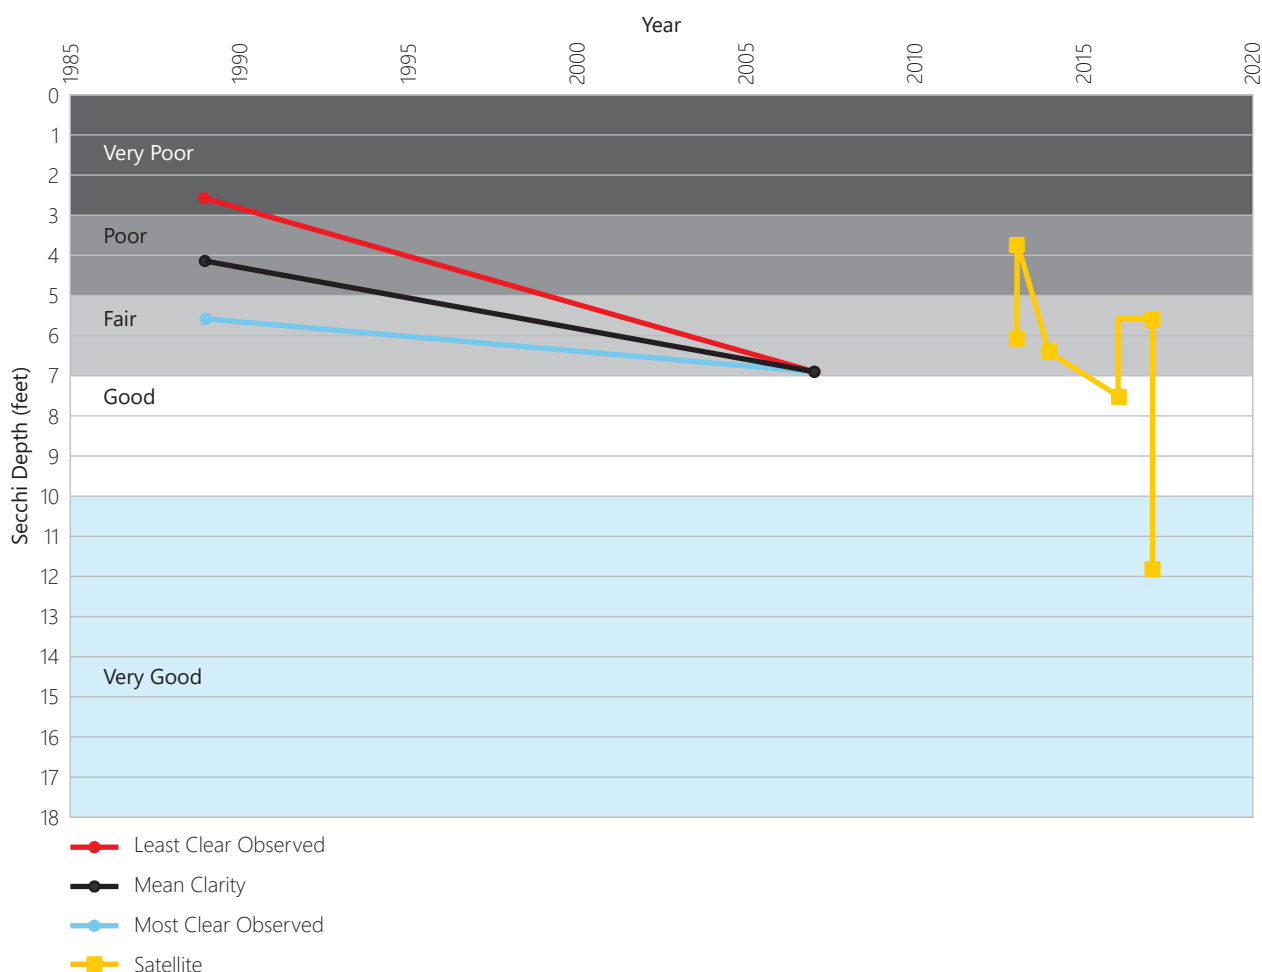
Figure 4
Summer (June Through August) Secchi Depth and Satellite Ranges for Voltz Lake

averaged only two feet.¹⁶ Satellite estimates made remotely between 2001 and 2011 (Figure 4) ranged from 2.9 feet to 12.5 feet, with an average of about 6.6 feet, indicative of generally poor to fair water quality. Based upon the available information, Voltz Lake's water clarity is rather poor and has not changed significantly since monitoring began.

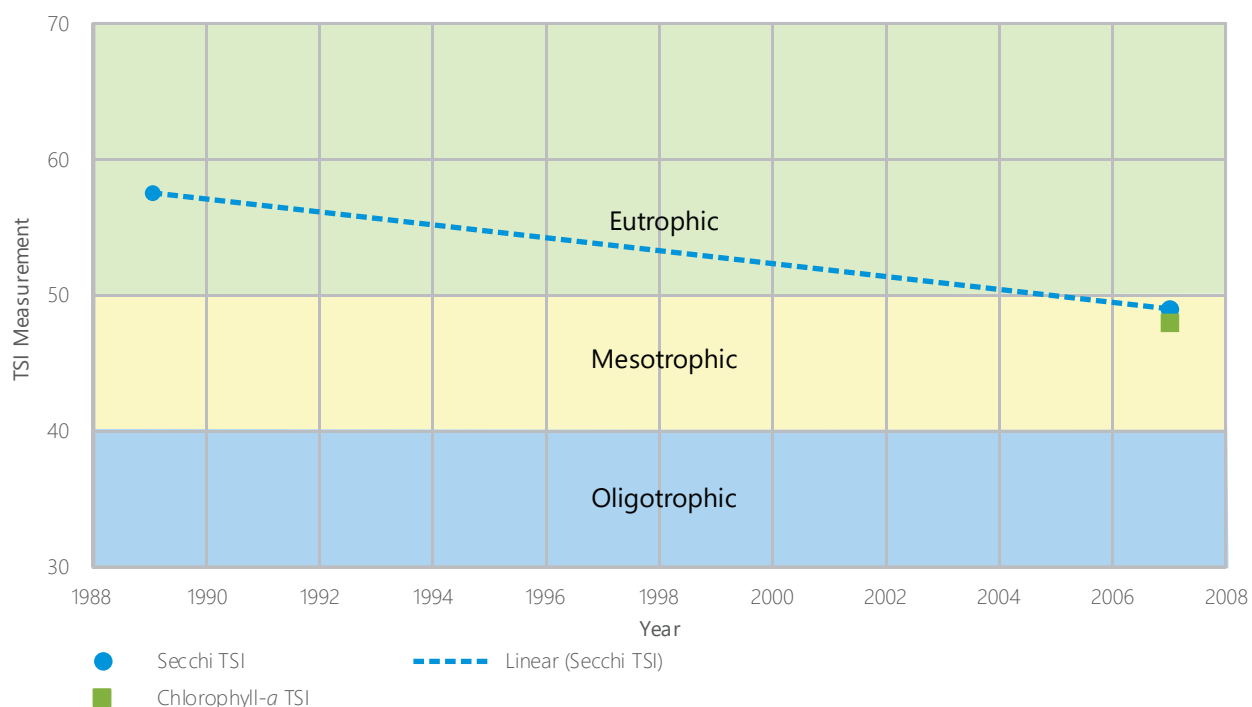
Figure 5
Summer (June Through August) Annual Average Trophic State Indices (TSI) for Voltz Lake

Voltz Lake's TSI values are plotted over time in Figure 5. As can be seen from this graphic, TSI values from 1989 to 2007, based mostly upon Secchi depth (there was only a single chlorophyll-*a* concentration measurement), have changed very little since 1989, and indicate mesotrophic bordering on eutrophic conditions. Satellite measurements taken in the last five years indicate eutrophic conditions. Such lakes support an abundance of aquatic plant growth, sometimes to nuisance levels, and may support productive fisheries. This trophic state is supported by USGS data collected in 2007 that reported a total phosphorus concentration (0.038 mg/L) above the guideline recommended by SEWRPC (0.020 mg/L) as the value above which water quality problems are likely to occur.

Note: Comparatively little data was available for Voltz Lake. June-August data of each year was averaged to produce the resultant values.

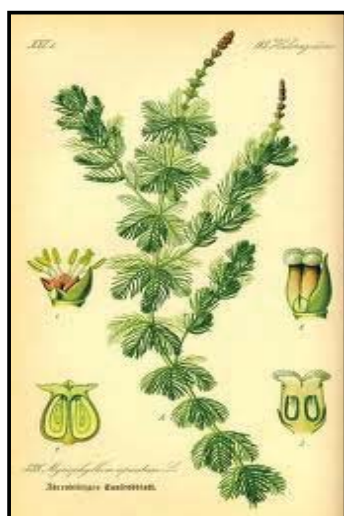
Figure 6
Eurasian Water Milfoil (*Myriophyllum spicatum*)

Identifying Features	Ecology
<ul style="list-style-type: none"> • Stems spaghetti-like, often pinkish, growing long with many branches near the water surface • Leaves with 12 to 21 pairs of leaflets • Produces no winter buds (turions) <p>Eurasian water milfoil is similar to northern water milfoil (<i>M. sibiricum</i>). However, northern water milfoil has five to 12 pairs of leaflets per leaf and stouter white or pale brown stems</p>	<ul style="list-style-type: none"> • Hybridizes with native northern water milfoil, resulting in plants with intermediate characteristics • Invasive, growing quickly, forming canopies, and getting a head-start in spring due to an ability to grow in cool water • Grows from root stalks and stem fragments in both lakes and streams, shallow and deep; tolerates disturbed conditions • Provides some forage to waterfowl, but supports fewer aquatic invertebrates than mixed stands of aquatic vegetation

EWM, one of eight milfoil species found in Wisconsin, is the only milfoil species known to be exotic/nonnative (see Figure 6). This plant can grow profusely in nutrient-rich lakes impeding boating and recreational use. Because of this management concern, EWM is actively managed by mechanical and chemical means in many Southeastern Wisconsin lakes. In recent years, EWM/native northern milfoil hybrids have been observed in some Wisconsin lakes. These hybrids pose a difficult management problem: not only do hybrids grow quickly like EWM, but hybrids appear to be more tolerant to aquatic herbicides such as 2, 4-D and Endothall that are commonly used to manage EWM.¹⁷ EWM/native milfoil hybrids have not yet been identified in Voltz Lake. EWM was positively identified as part of the 2001 survey and was the second most dominant plant in the Lake at that time. The presence of invasive milfoil species is a management concern. The VLMD manages nuisance aquatic vegetation using herbicides. Increasing vigilance has been devoted to protecting native aquatic plants to promote their spread into areas infested with EWM.

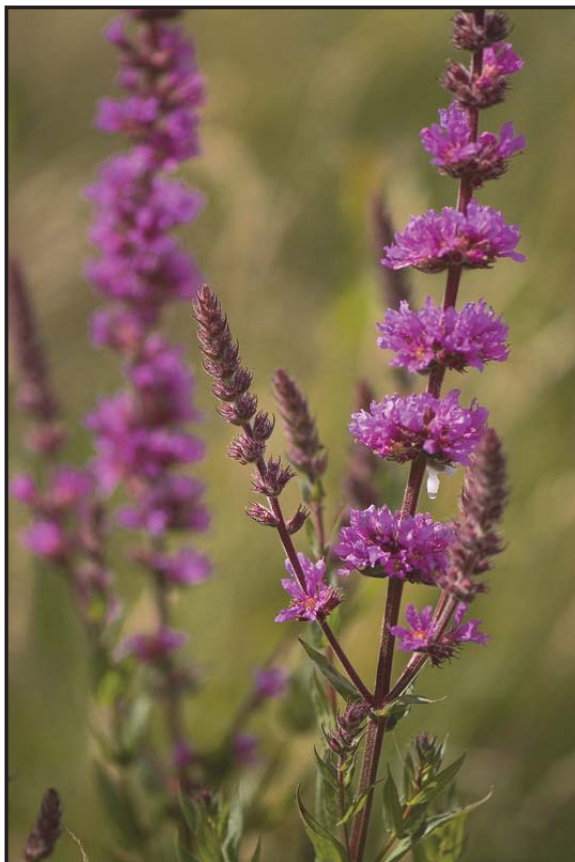
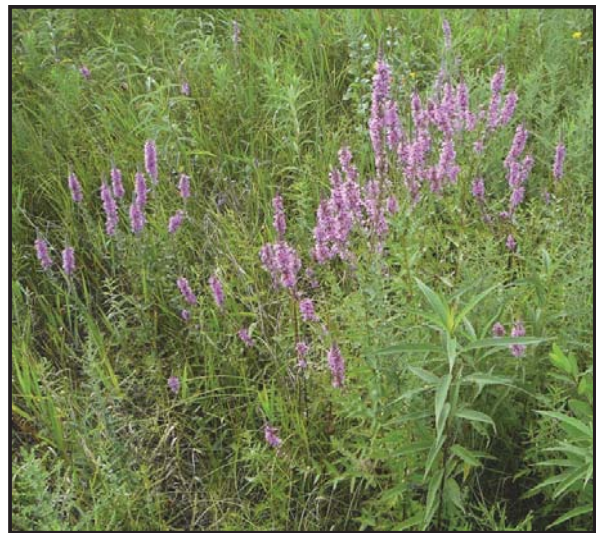
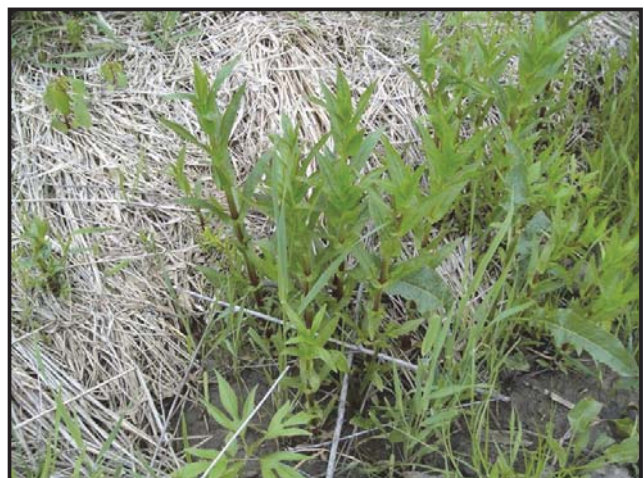
Figure 8
Purple Loosestrife (*Lythrum salicaria*)

- Found in shallows, along shores, and in wet to moist meadows and prairies
- Invasive and continues to escape from ornamental plantings
- Galerucella beetles have been successfully used to control purple loosestrife. Plants may also be dug or pulled when small, but they subsequently should be placed in a landfill or burned. Several herbicides are effective, but application near water may require permits and aquatic-use formulas

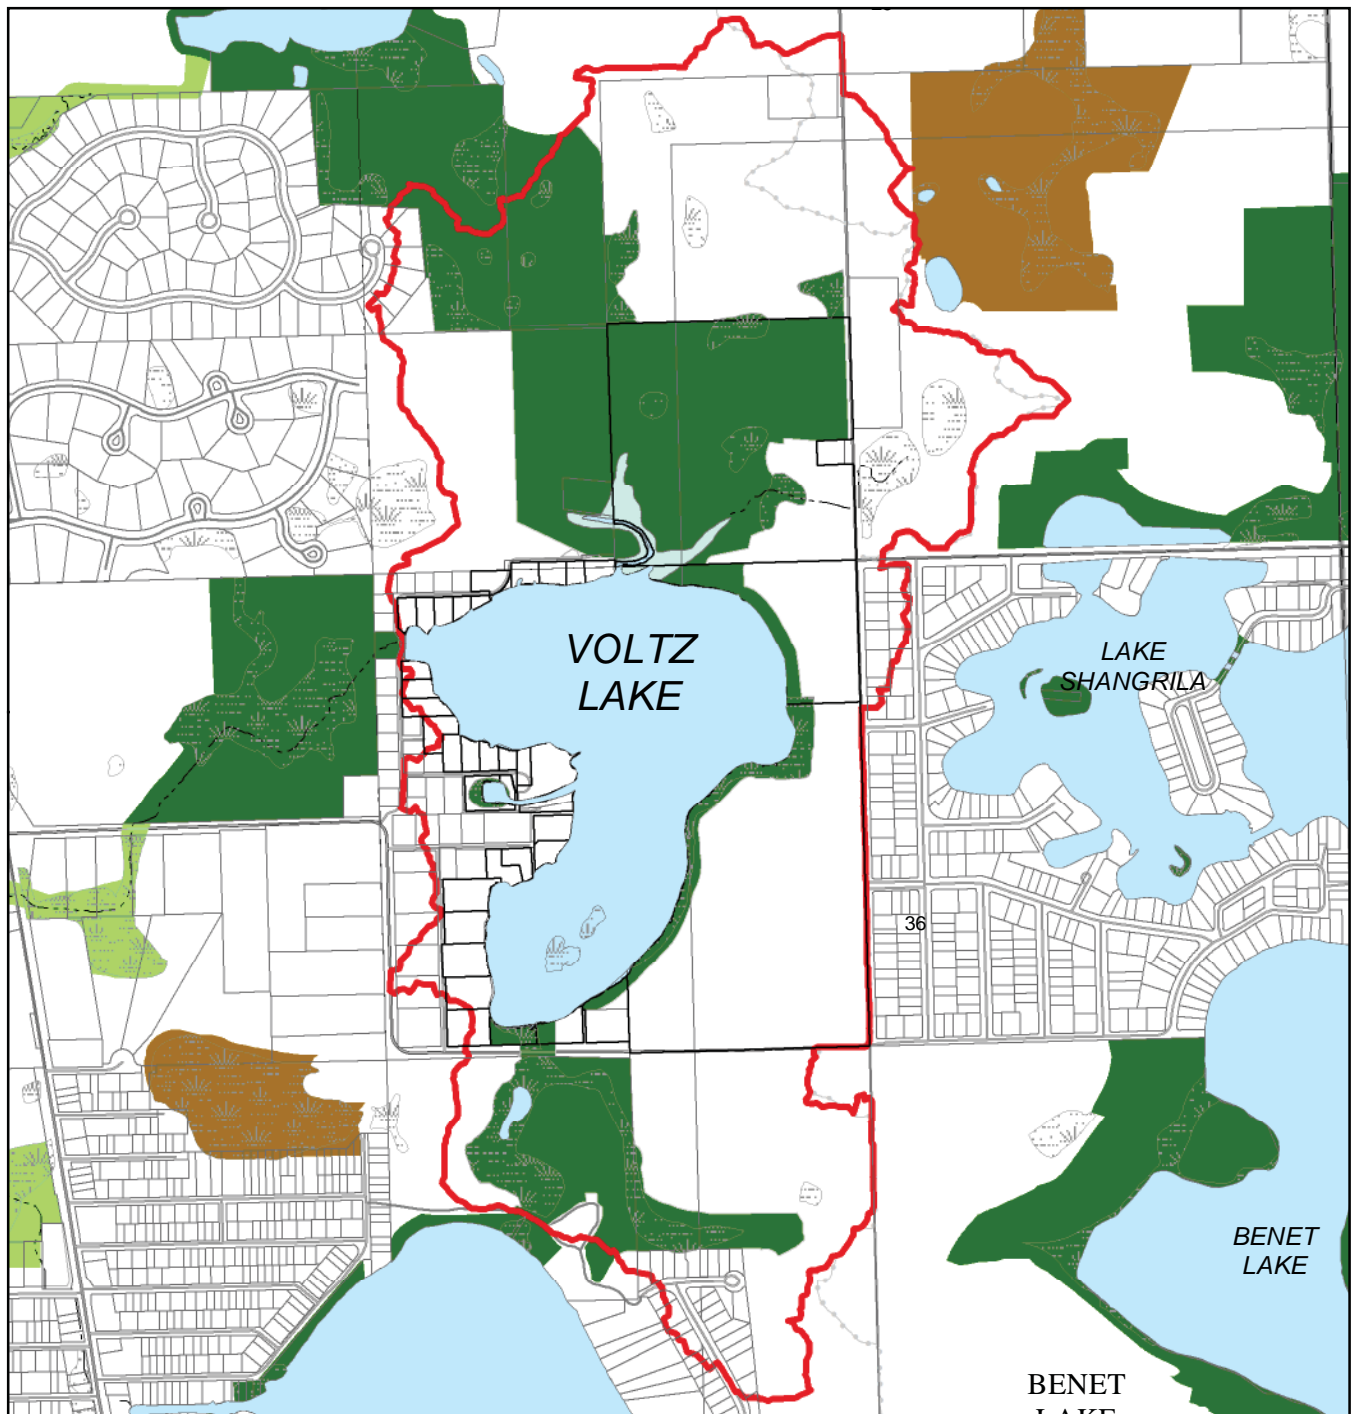
Map 3
Environmentally Significant Areas Within the Voltz Lake Watershed: 2015

As shown on Map 3, primary environmental corridor areas occupy nearly 171 acres of land and water area (including the Lake itself) in the Lake's watershed, much of it in close proximity to the Lake. Preserving these areas is critically important to maintaining the ecological integrity of the Lake. As noted above, Voltz Lake itself is especially rich in aquatic plant growth. Voltz Lake Marsh is designated as a natural area of county-wide or regional significance.
