CENTER LAKE USE REPORT UPDATE LR-3

Prepared by the Southeastern Wisconsin Regional Planning Commission for Kenosha County, Wisconsin October 2017

This Lake Use Report Update is a product of the Lake and Stream Resources Classification Project for Kenosha County Wisconsin: 2017. This report is available online at co.kenosha.wi.us.

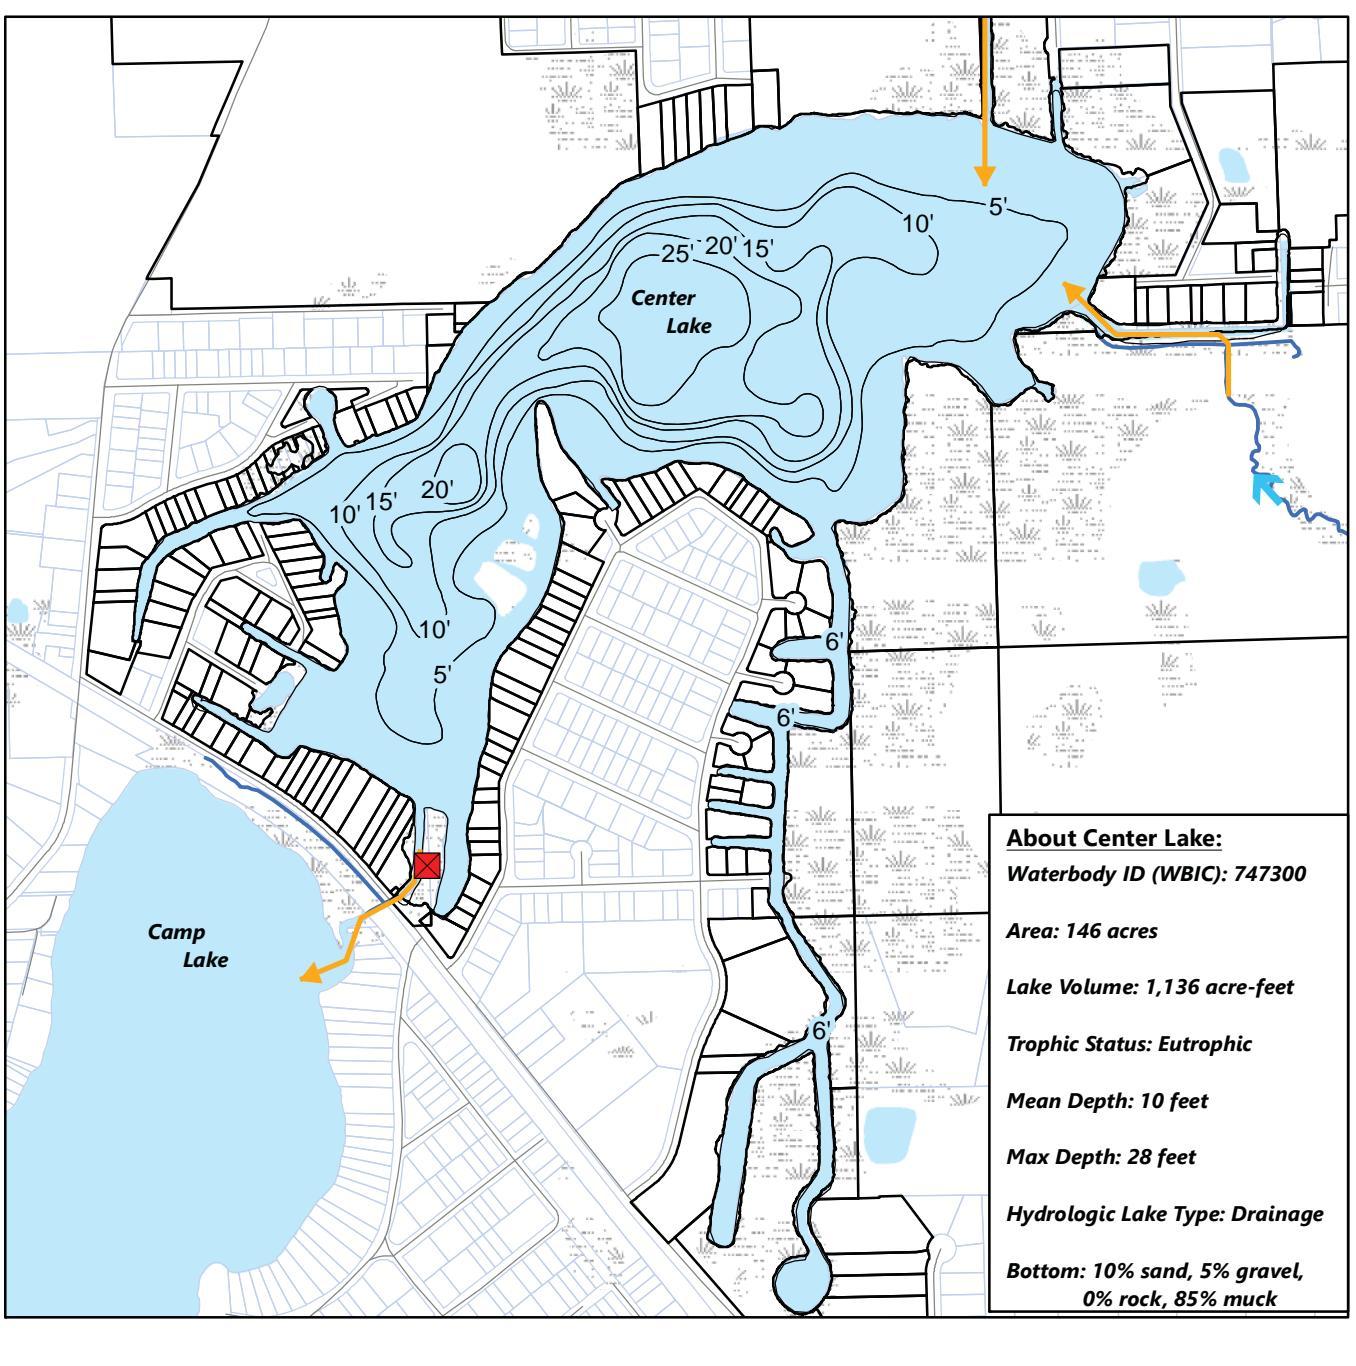
Map 1 **Center Lake**

LAKE OUTLET STRUCTURE -15'-WATER DEPTH CONTOUR IN FEET SURFACE-WATER FLOW PATH **RIPARIAN PARCEL BOUNDARY** STREAM AND FLOW DIRECTION PARCEL BOUNDARY SURFACE WATER 900 Feet 450 WETLAND

Based upon recent orthophotography, Center Lake has a surface area of 146 acres.¹² As shown on Map 1, Center Lake has an elongated basin with a northeast-southwest orientation and a maximum depth of 28 feet. According to 1960 depth soundings published by the WDNR, Center Lake contains 1,136 acre-feet of water. The Lake has a normal water surface elevation of 741.50 feet above National Geodetic Vertical Datum, 1929

A low-head dam forms the Lake's outlet discharging to a dug channel passing under County Trunk Highway (CTH) SA at the southwest corner of the Lake (Figure 1, Map 1). This water enters Camp Lake a short distance downstream. Flow from Center Lake to Camp Lake may likely be imperceptible during extended dry weather due to the small elevation difference between the Lakes and low flow volume. Some groundwater also discharges to Center Lake and its tributary streams.

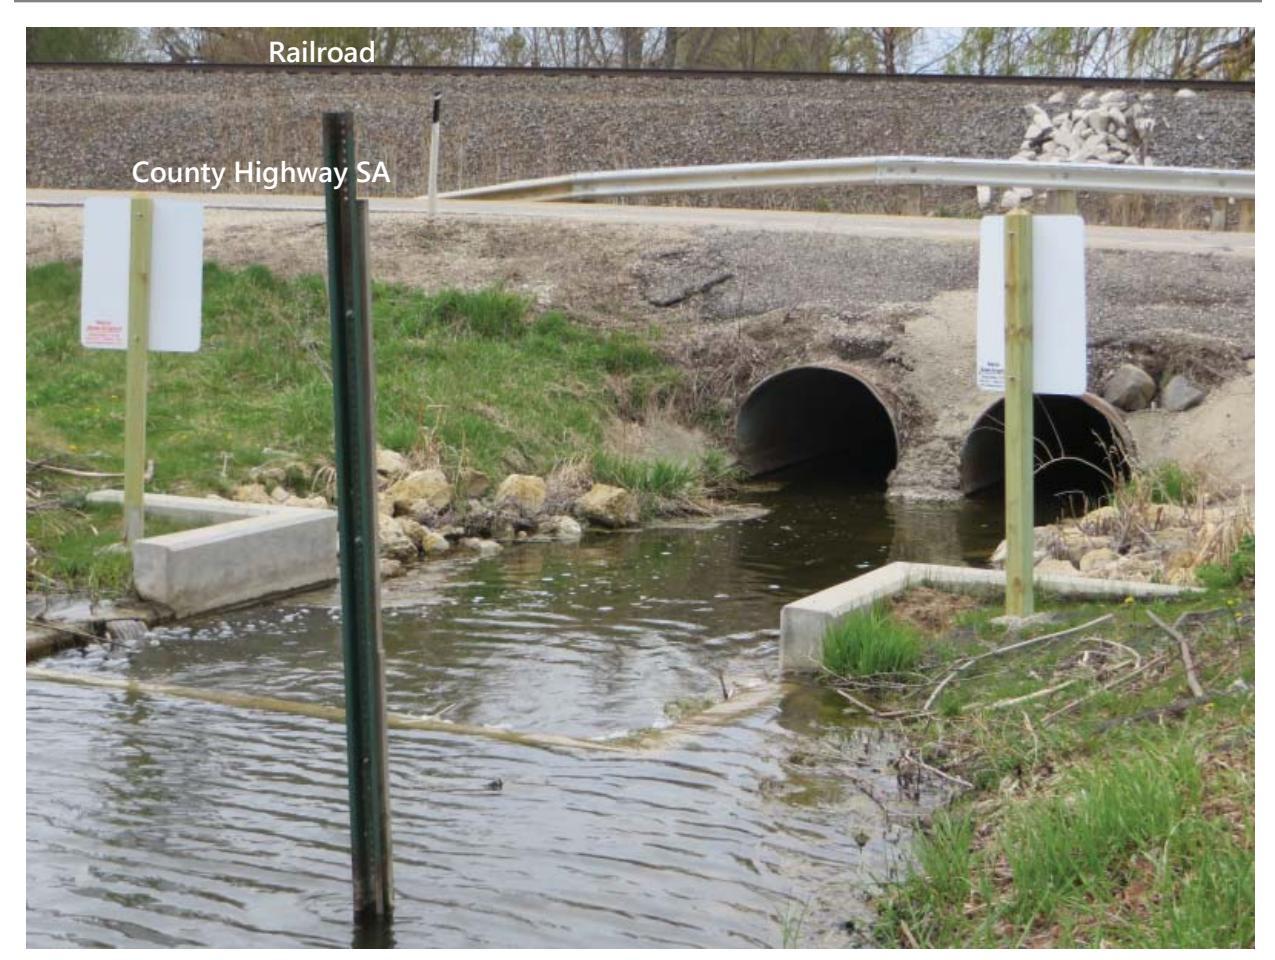
Figure 1 Center Lake Outlet Structure

Note: The outlet dam in the foreground is used to control Center Lake's elevation. After leaving Center Lake, water passes under County Trunk Highway SA and the Canadian National Railroad before reaching Camp Lake.

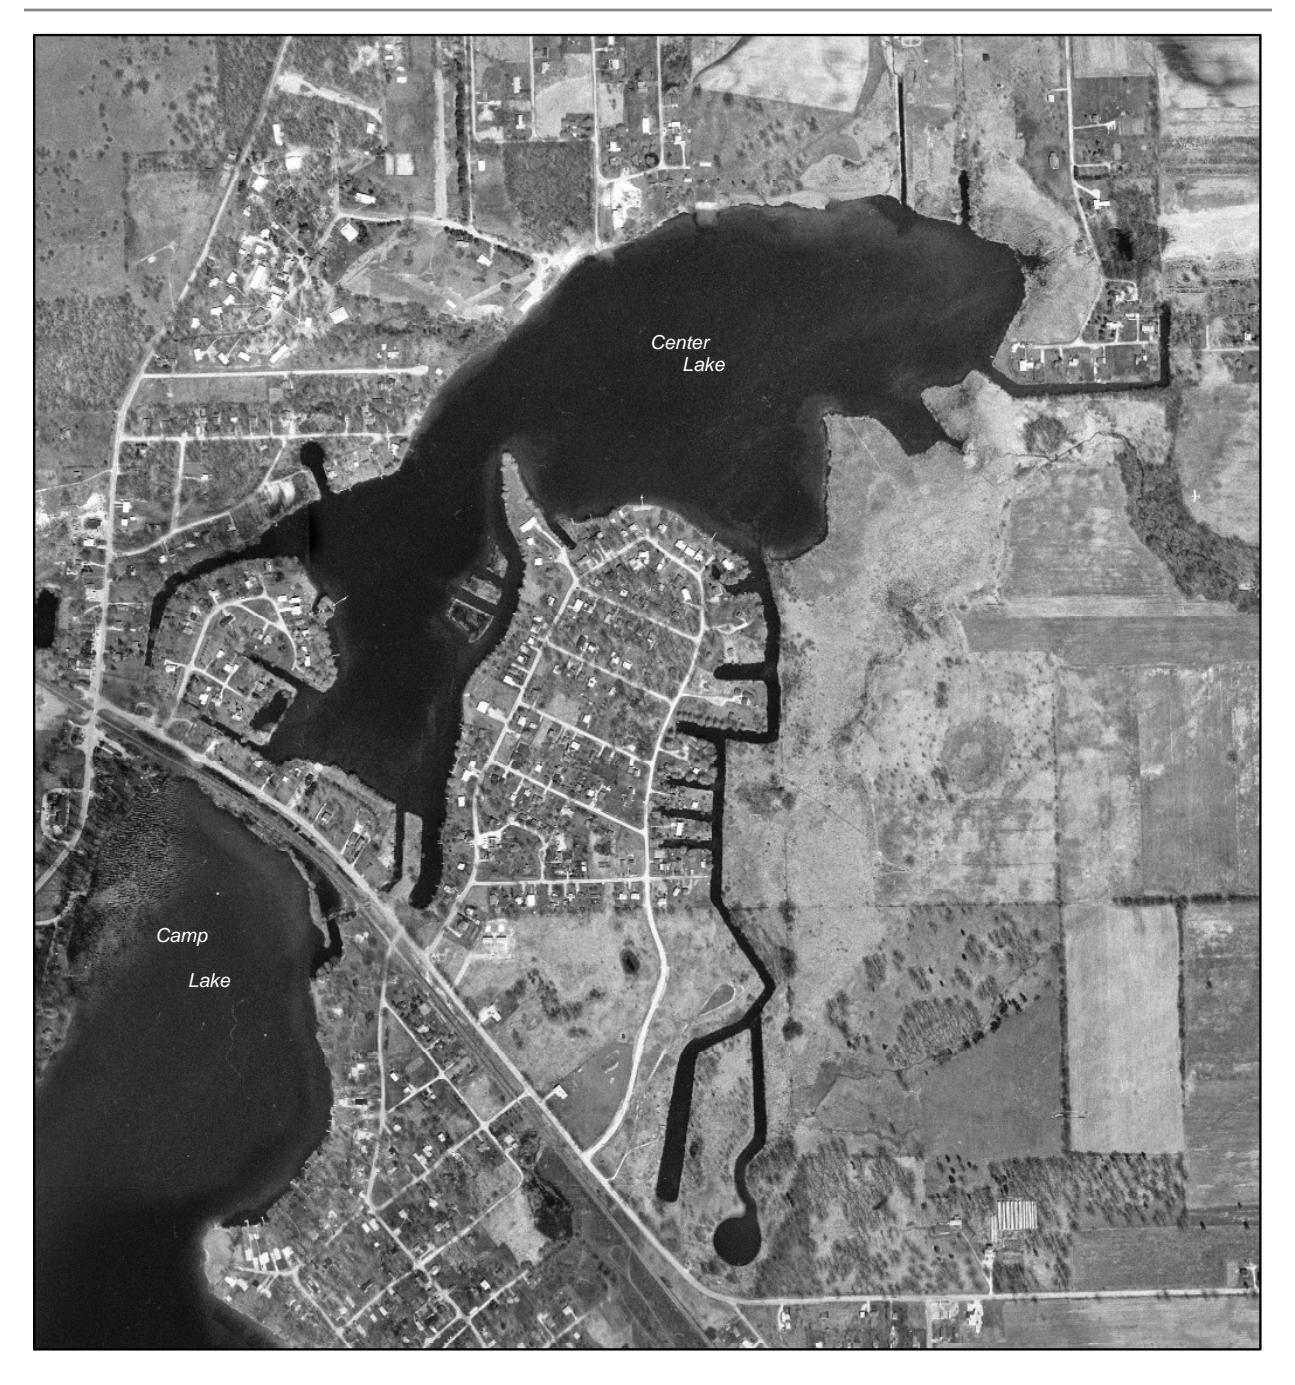
Figure 2 1970 Aerial Photograph of Center Lake

Date of Photography: 1970

Land use immediately adjacent to Center Lake has not significantly changed since 1970 (see Figures 2 and 3). Land use as of 2010 in the Center Lake watershed is illustrated on Map 2 and summarized in Table 2. In 2010, agricultural lands accounted for about 45 percent of total watershed land use. Wetlands and woodlands covered another 12 and 6 percent, respectively, of the total watershed area. Urban uses accounted for about 29 percent of the watershed, with residential and transportation/communication/utility land uses accounting for about 80 percent of the urban land use total. Planned 2035 land use (Table 2) suggests significant changes within the Center Lake watershed. The forecast suggests that nearly all agricultural lands within the watershed will be converted to residential use, resulting in a nearly 60 percent decrease in total rural land uses and a 144 percent increase in urban land uses. Low-density and multi-family residential uses, and recreational uses, account for most of the planned increase in urban land use.

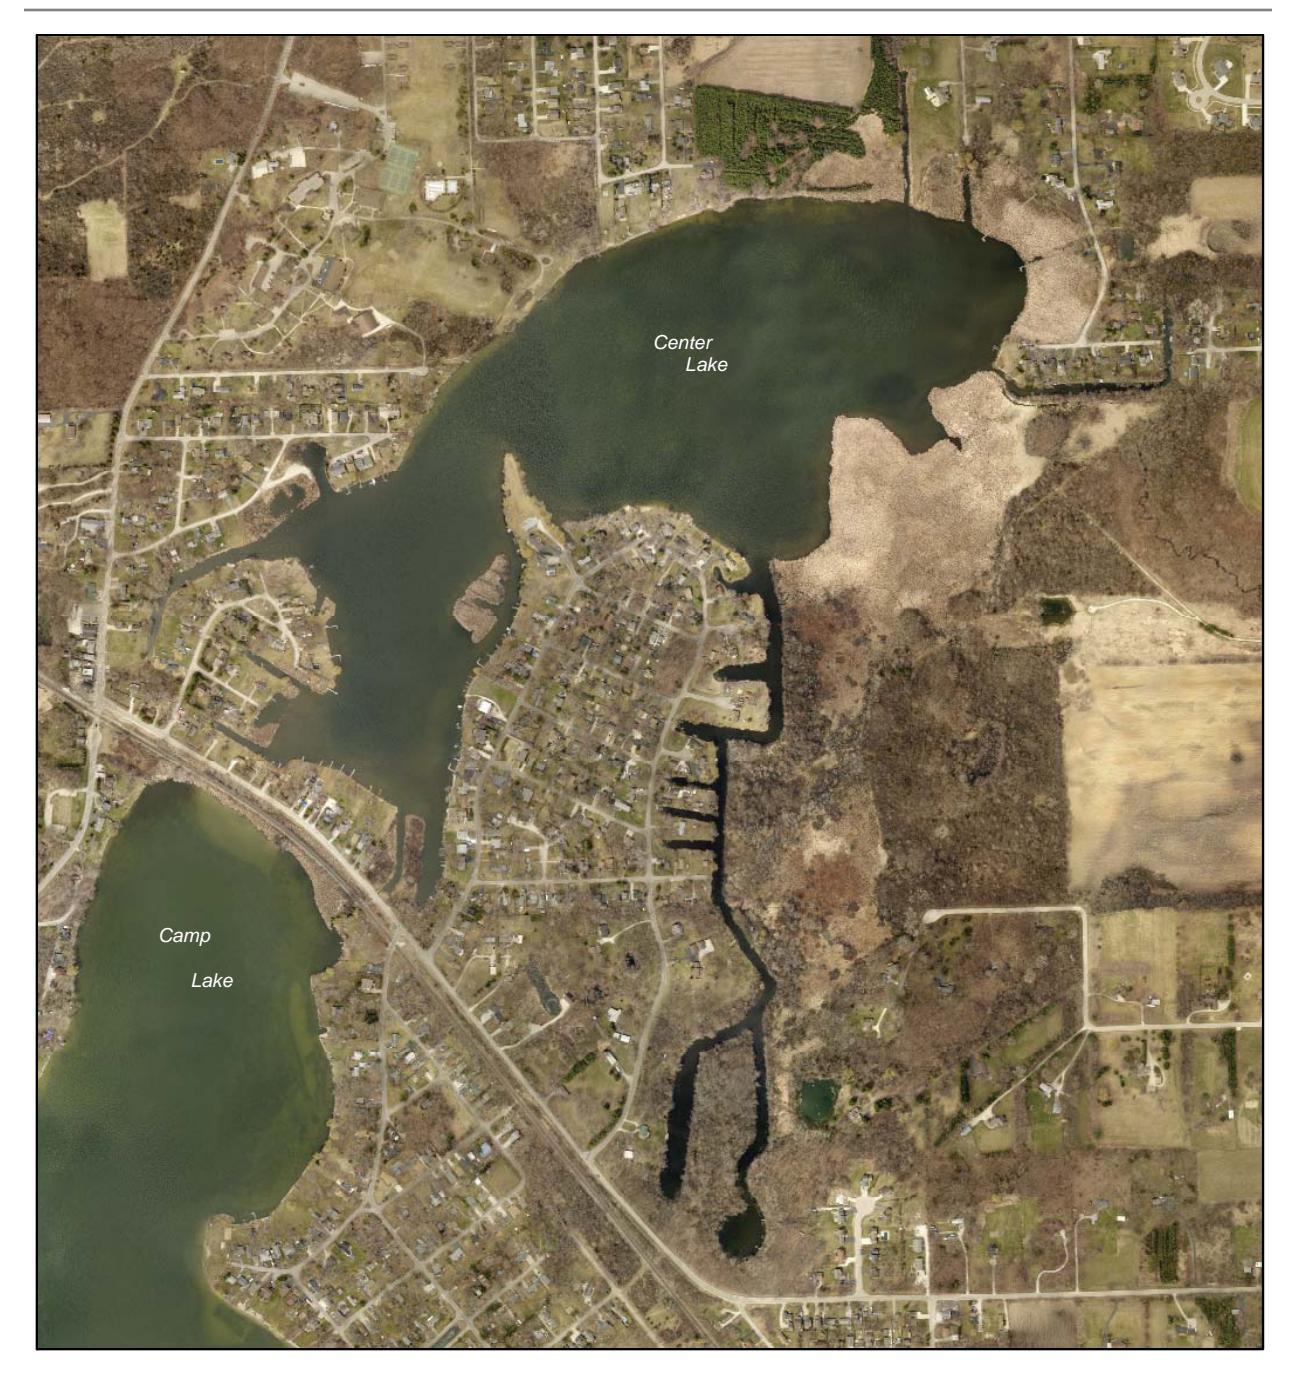
Figure 3 2015 Orthophotograph of Center Lake

Date of Photography: 2015

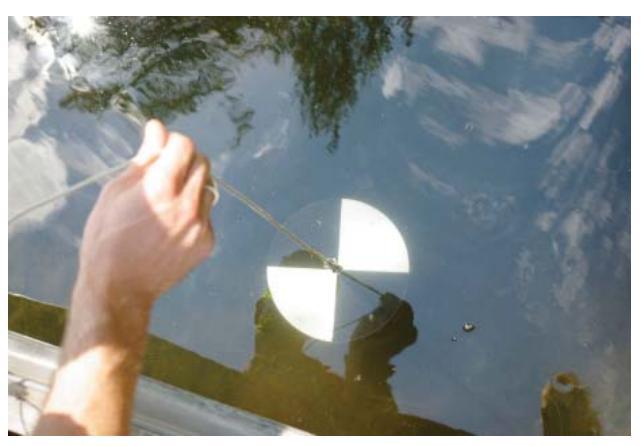
Figure 4 Measuring Water Clarity with a Secchi Disk

been developed to allow lake water clarity to be compared and contrasted. Water clarity is measured with a Secchi disk (Figure 4). "Secchi depth" is the distance below the water surface a Secchi disk can be seen

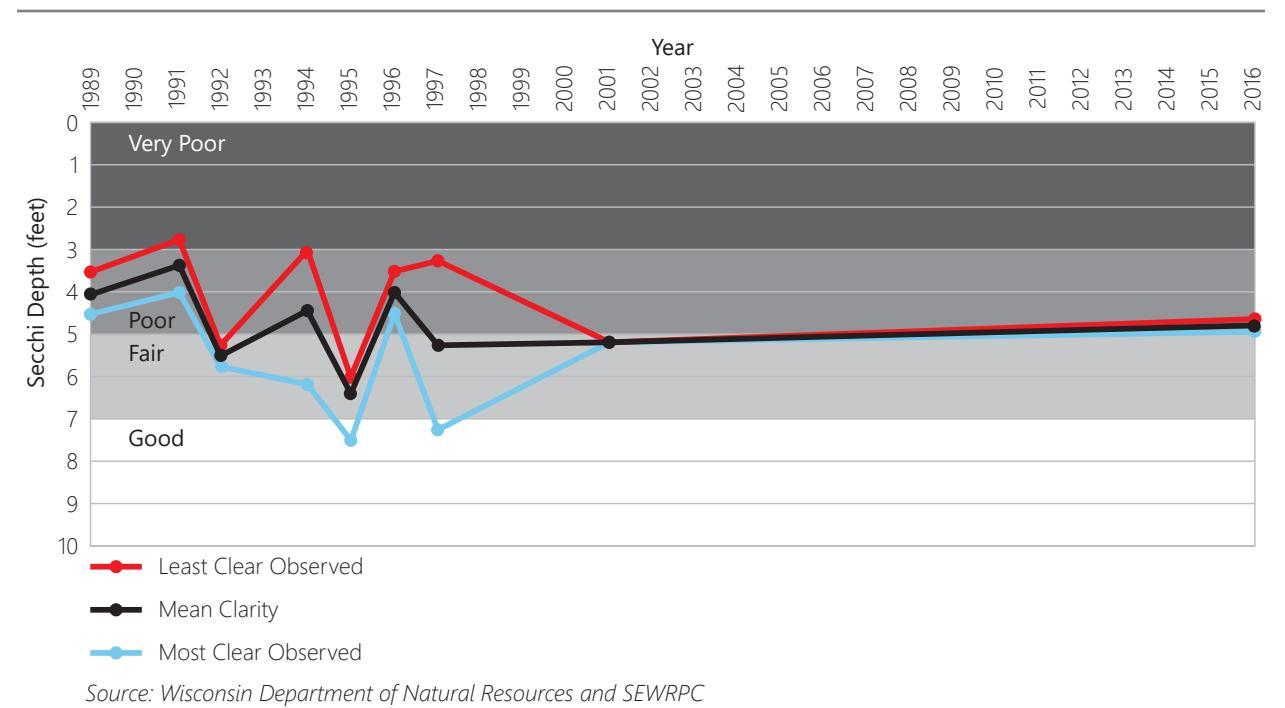
Figure 5 Summer (June Through August) Secchi Depth Ranges for Center Lake

under carefully prescribed conditions. Secchi depth has been occasionally measured in the Lake and the results over time are summarized graphically in Figure 5. On average, water clarity has been rather poor, with Secchi depth readings ranging between three and six feet and typically averaging around four to slightly more than five feet. Water clarity has also been estimated from satellite imagery,¹⁸ averaging 3.6 feet between 2003 and 2011, which generally agrees with values actually measured on the Lake. Furthermore, more recent remote sensing techniques suggest that the Lake is fairly turbid in most areas.¹⁹ Based upon the available information, Center Lake's water clarity is rather poor and has not changed significantly since monitoring began.

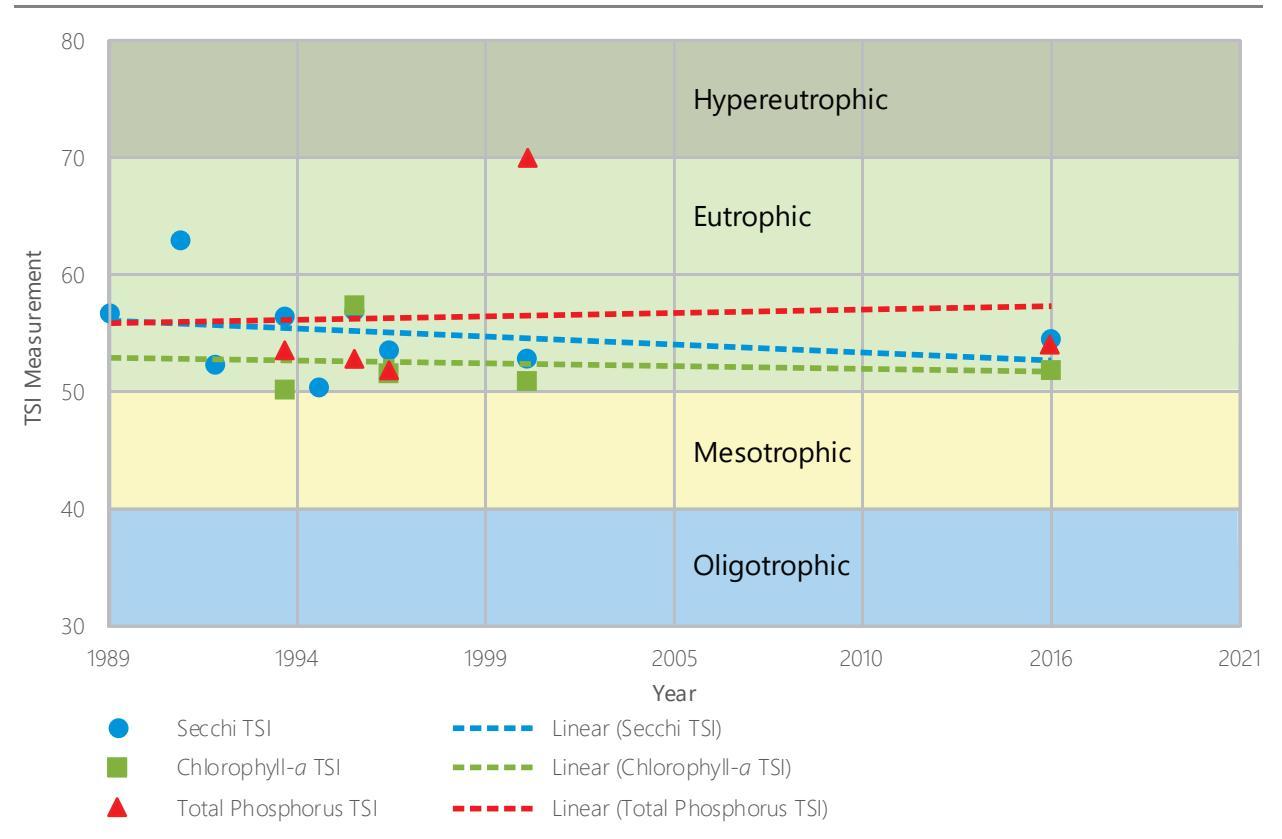
Center Lake's TSI values are plotted over time in Figure 6. As can be seen from this graphic, TSI values have been relatively static over the past 30 years, indicating persistent eutrophic conditions. The WDNR classifies Center Lake as eutrophic. Unlike neighboring Camp Lake, chlorophyll-a TSI values have only slightly decreased over the time period with a corresponding and logical slight increase in secchi depth TSI. Similar to Camp Lake, Spring and fall total phosphorus concentrations decreased between 2001 and 2016, suggesting that water quality is improving.²⁰

Note: Comparatively little data was available for Center Lake. June-August data of each year was averaged to produce the resultant values.

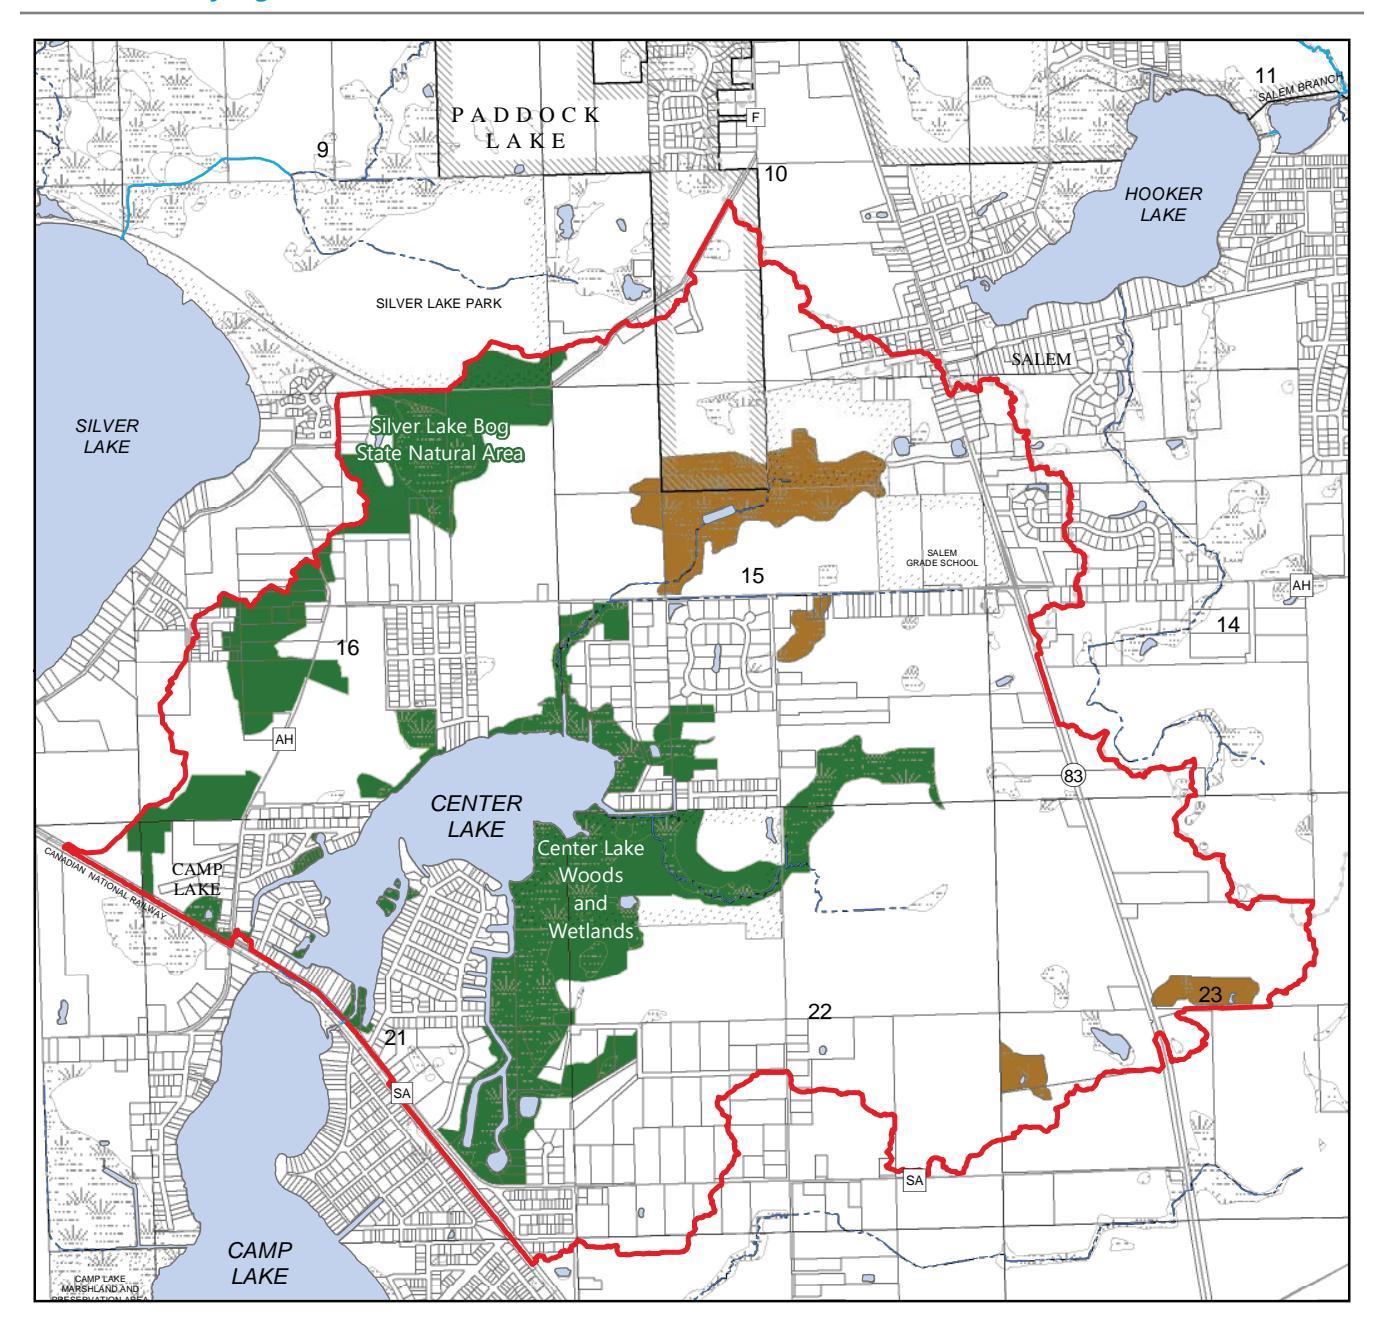
Map 3 Environmentally Significant Areas Within the Center Lake Waterhsed: 2015

- ISOLATED NATURAL RESOURCE AREA
- WETLANDS

Silver Lake Bog State Natural Area lies in the northwest corner of the Center Lake watershed (see Map 3). This 18-acre tract contains one of the better acid bogs in the Region. This area is designated as a natural area of State-wide significance. Center Lake Woods and Wetlands (see Map 3) is a 72-acre tract containing species-rich ravine woods associated with good quality wetlands; it is considered an area of local significance. Center Lake has been designated as critical aquatic habitat area under the SEWRPC's Critical Habitat Designation program on the basis of its ability to provide ideal waterfowl, marsh wildlife, and critical fish species habitat.28 The Lake is considered an aquatic area of local significance, important to the overall health of aquatic plants and animals.

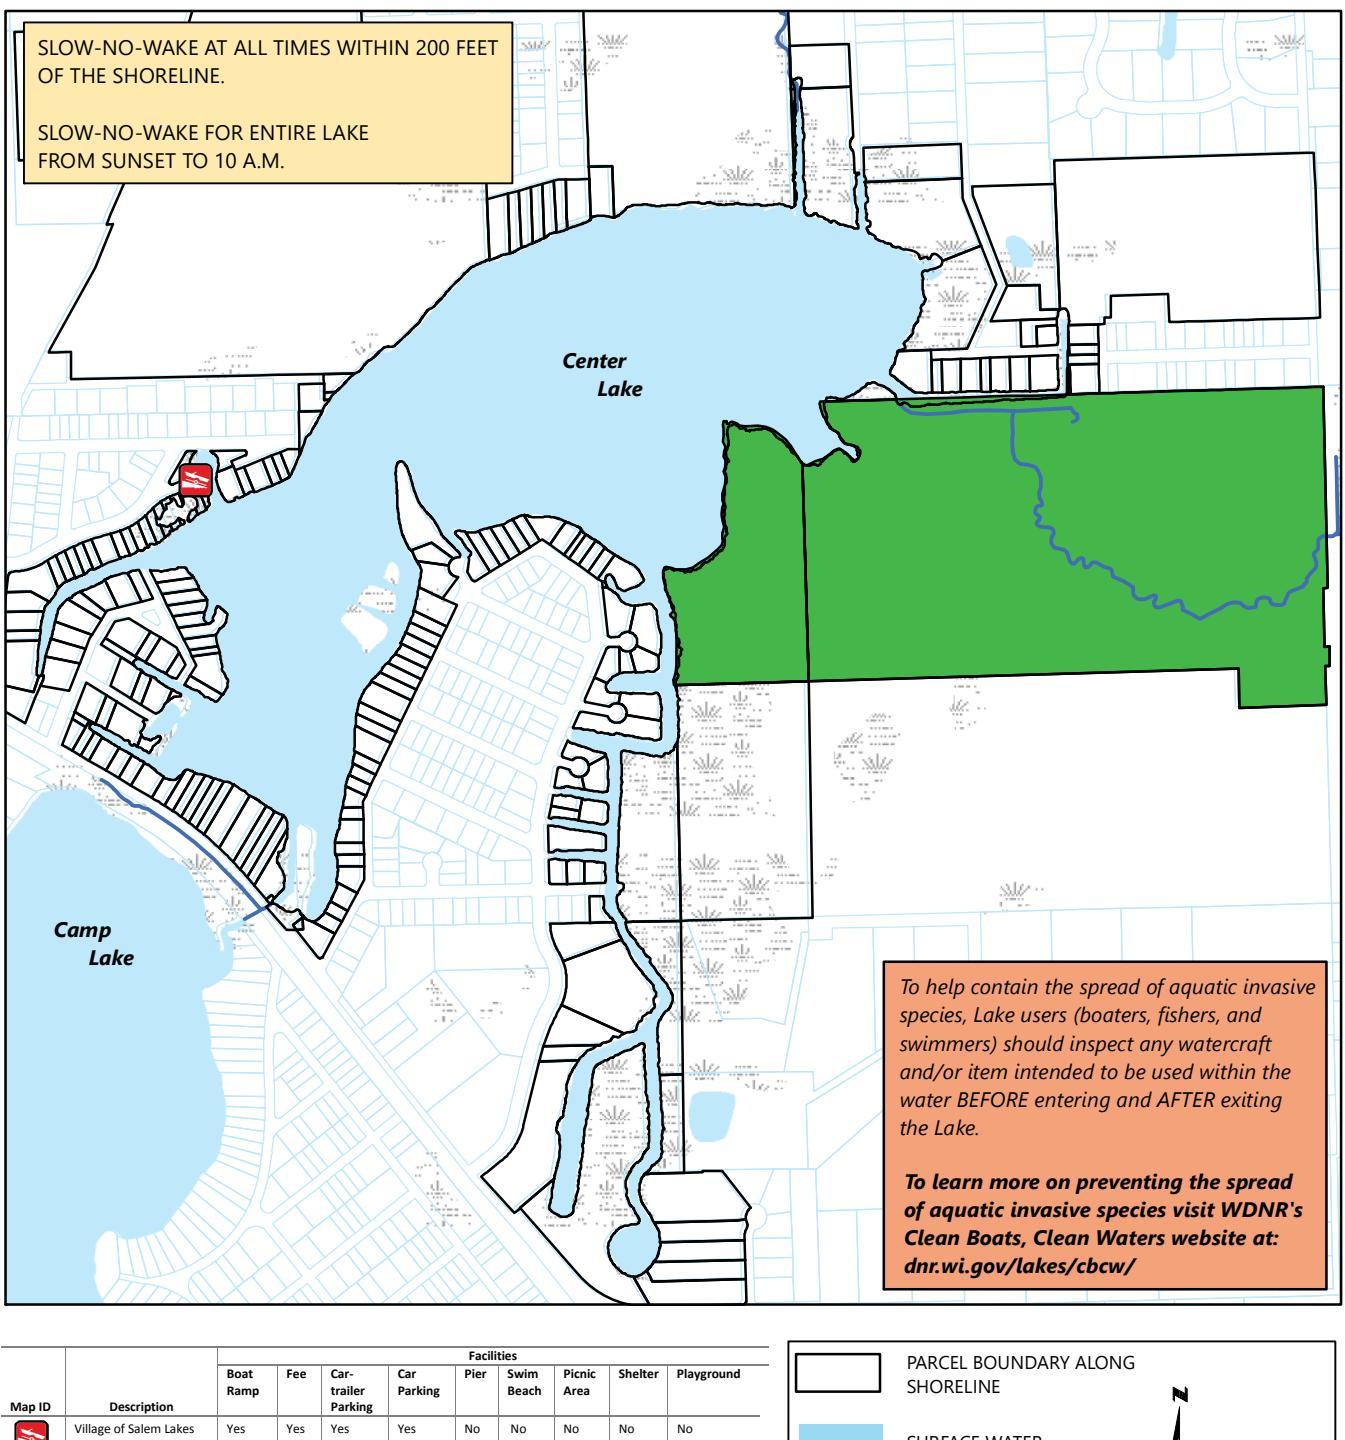
Map 4 Recreational Use on Center Lake: 2015

Note: For additional lake information or boating regulations go to: dnr.wi.gov/lakes/lakepages/Results.aspx

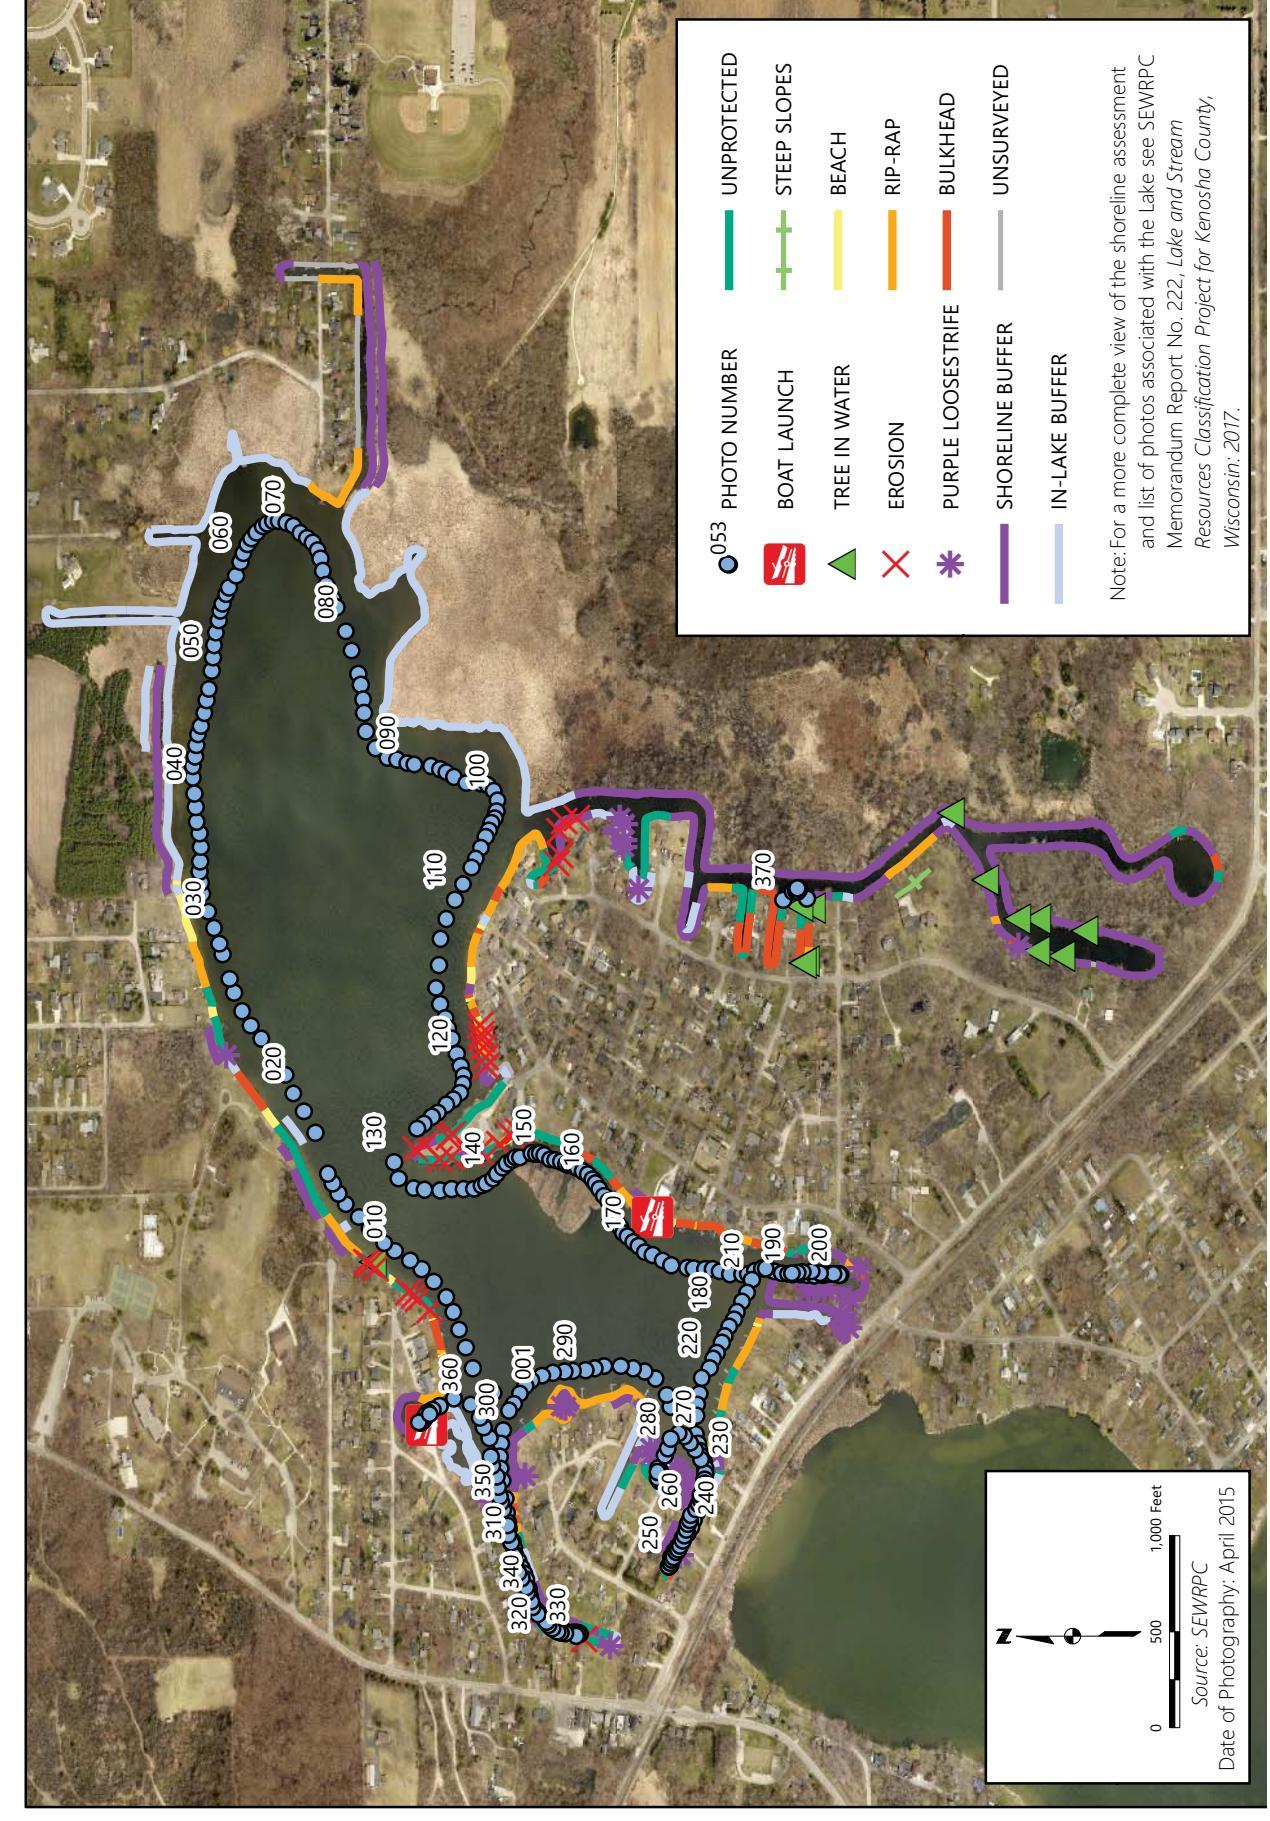
Center Lake's shoreline includes stretches of protected shoreline (either artificial or natural) as well as some areas of unprotected shoreline, such as where a riparian owner mows lawn to the water's edge (see Map 5). About 82 percent of Center Lake's shoreline is protected by natural features (63 percent) or artificial shoreline protective structures such as riprap or bulkhead (19 percent). Never the less, many actively eroding shoreline areas were noted as part of SEWRPC's August 2014 field survey.³⁰, ³¹
